A beszercei evangélikus templom

A beszercei evangélikus templom építéstörténete

The Lutheran Church in Bistrița

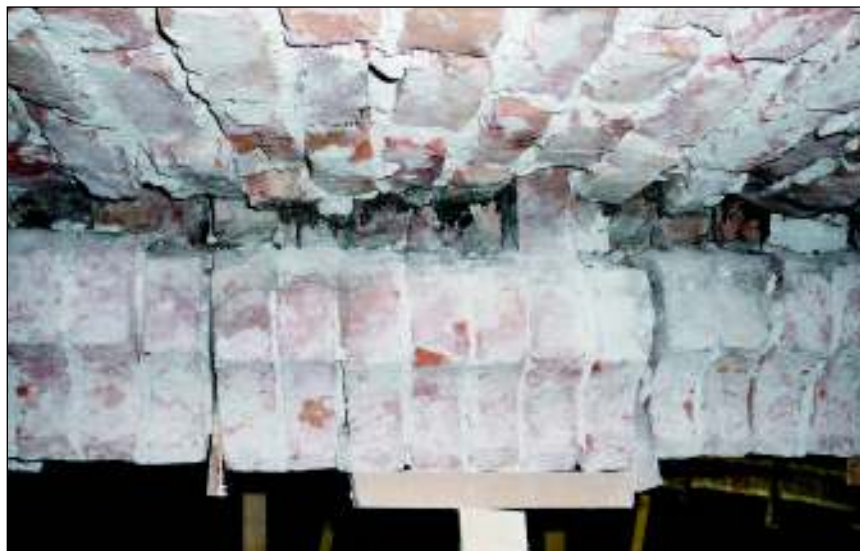
Beside the two longitudinal cracks on the nave's vaulting – caused by the shifting and deflecting of the supports – from the scaffolding the technological cracks from between the vault panels and the ones between the ribs and vault panels were also visible. The building archaeology research revealed that the ribs were walled from two types of shaped bricks, the longer ones (with an additional neck-shaped part) were weaved into the vaulting, while the shorter ones were fixed only to the vault and the other elements of the brick rib by mortar. The frequency within the rib of the bricks with neck part is in certain areas one in three or four; however in other parts only one in nine was weaved into the vaulting. In the places where the cracks developed, after removing the plaster, it became apparent that the neck of the weaved-in brick was broken; this is why the supported rib section had shifted from its original position.

■ **7. kép:** Eredeti helyéről kimozdult bordaszakasz. © UTILITAS
 ■ **Photo 7.** Rib section shifted from its original position. © UTILITAS

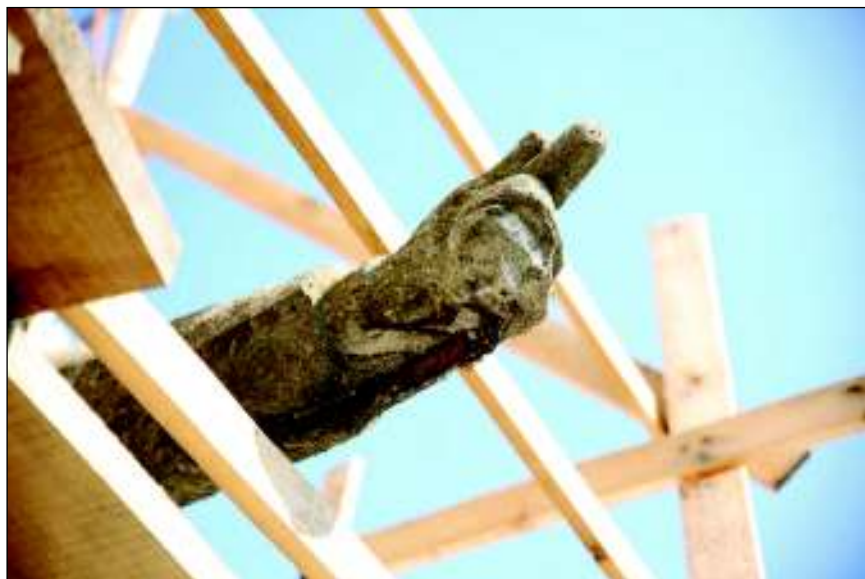
■ Foto 1. Mână reconstituită din mortar de ciment
■ Photo 1. Rearrangement of one hand out of cement mortar

As previously mentioned, such interventions were carried out in an inadequate manner, with cement mortar and therefore, their colour appears to be different than that of the original stone. The completions obtained through previous interventions must be replaced with artificial stone that should match the original stones both as structure and nuance. Artificial stone can be also made from powders or mineral aggregates resulting from the original rock.

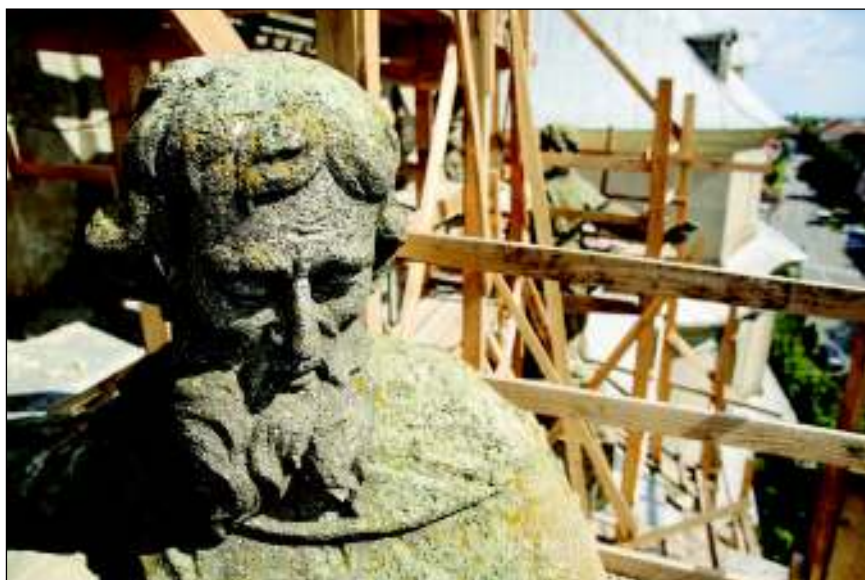
■ Foto 2. Licheni și alge pe suprafața statuii
■ Photo 2. Lichens and algae on the statue's surface

■ The statues are made of individual blocks of volcanic tuff originating from Seini (Maramureș County) and their surfaces are highly deteriorated. The surfaces turned blackish and are heavily polluted with algae and lichens. The statues are also in a state of decay, on the one hand due to the erosion caused by meteoric water, and on the other, to the loss of elements, like arms that were sculpted separately and attached to the body by the means of metallic elements. The sculpted figures' arms have probably been repaired, reattached or even replaced several times already. It was noted that some elements were remade out of pieces of bricks and the missing parts were completed with cement-based mortar. Due to pollution, both colours and the areas that had supposedly been gilded are hardly noticeable nowadays. The damage is obvious especially on the statues' prominent parts, but their lower parts are quite damaged as well, with fissures and stone detachments probably also due to the corroded metallic rods endangering the statues' safety. Subsequent repairs can be noticed on each of the eight statues, carried out with a darker mortar with high cement content.

It is recommended that stone restoration interventions are wrapped up by impregnation interventions for hydrophobization purposes. This operation is necessary due to the fact that rain water trickles down those surfaces, infiltrating into the porous rock. These solutions do not close the material's pores; the stone can eliminate vapors but it stops humidity from getting into the stone's mass.

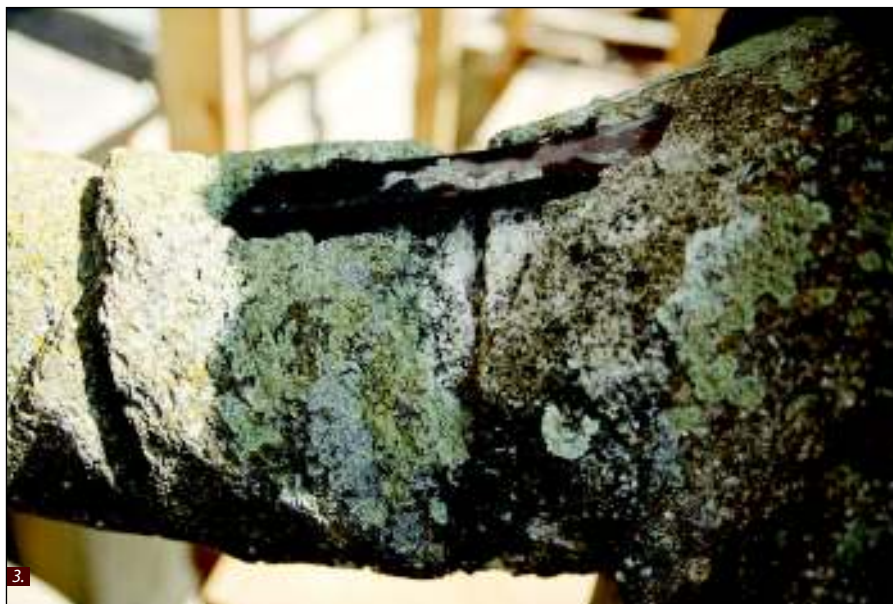
3.

■ **Foto 3.** Scoabe metalice corodate ■ **Foto 4.** Statuia superioară de la colțul sud-estic al turnului
 ■ **Photo 3.** Corroded metal rods ■ **Photo 4.** The upper levels' statue from the south-eastern corner

The sculptures will be restored on the premises. First of all, stainless steel rods will be implanted so as to fasten the sculpted figures' broken limbs. All unwanted material will be removed from the surface of the stones, including biological one. All the joints will be cleaned, the degraded lithic material will be consolidated and the cracks will be injected. Then the completions with artificial stone will be carried out, both on frames and on sculptures. The sculptures' accessories will be completed.

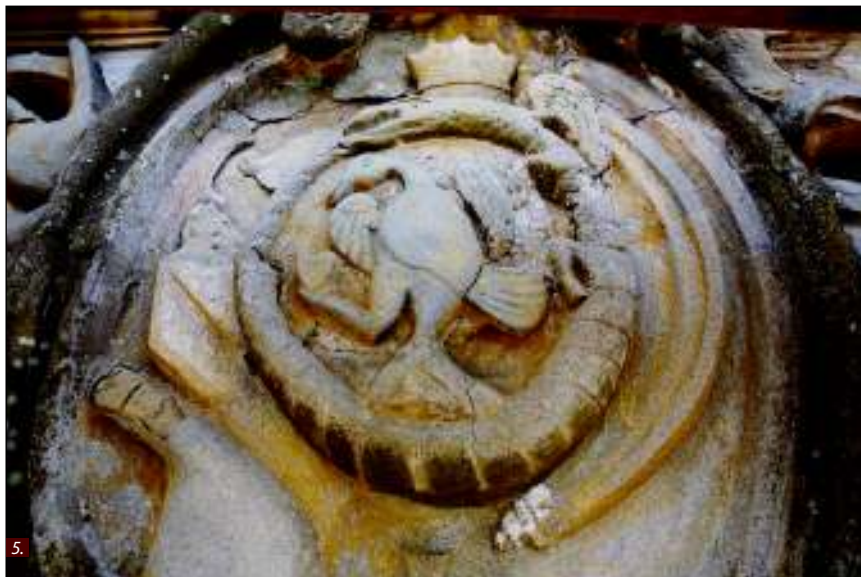
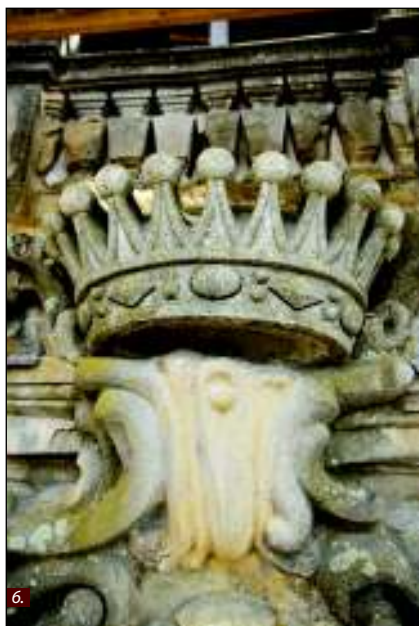
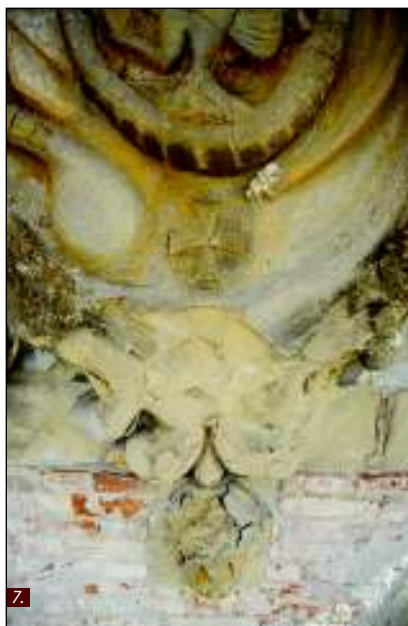
■ **Foto 5.** Partea centrală a blazonului familiei KÁROLYI ■ **Foto 6.** Partea superioară a blazonului și parapetul cu baluștri ■ **Foto 7.** Partea inferioară a blazonului cu lipsuri însemnate
■ **Photo 5.** Coat of arms of the KÁROLYI family, central part ■ **Photo 6.** Coat of arms of the KÁROLYI family, upper part and the balustrade ■ **Photo 7.** Lower part of the coat of arms with significant missing parts

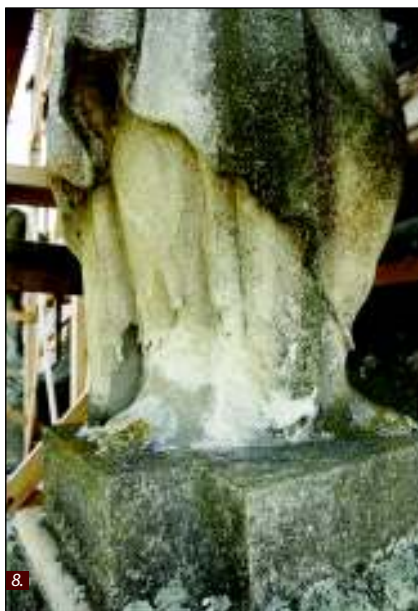
Cement-based mortar has a dense, impermeable structure and its application on the original porous, waterproof material led to an accentuation of the degradation. As a consequence of the salts' crystallization, tensions are building up inside the construction materials. It is an irreversible phenomenon affecting the long-term resistance of the material, leading to fissures, splinters crumbling and tearing. Under that thin

■ Foto 8. Degradări caracteristice părții inferioare a statuilor

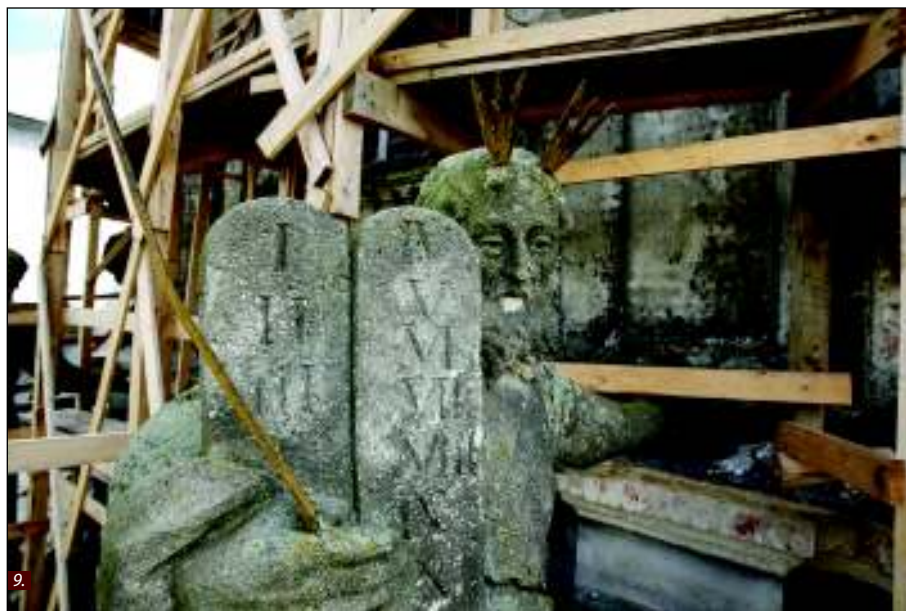
■ Foto 9. Statuia lui Moise cu atribute metalice corodate și deformate

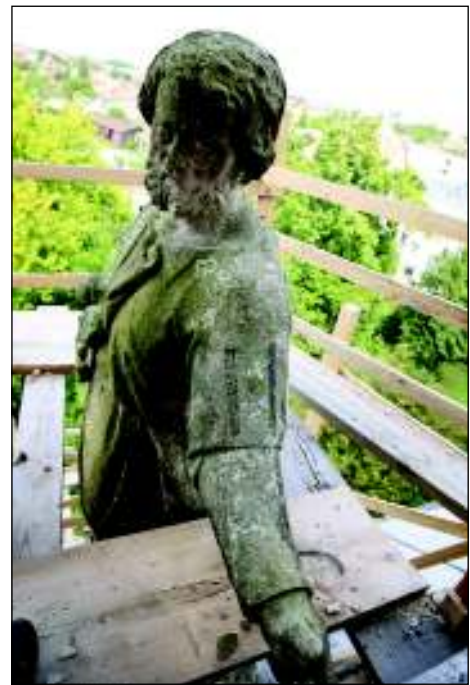
■ Foto 10. Mână reconstituită disproporțional

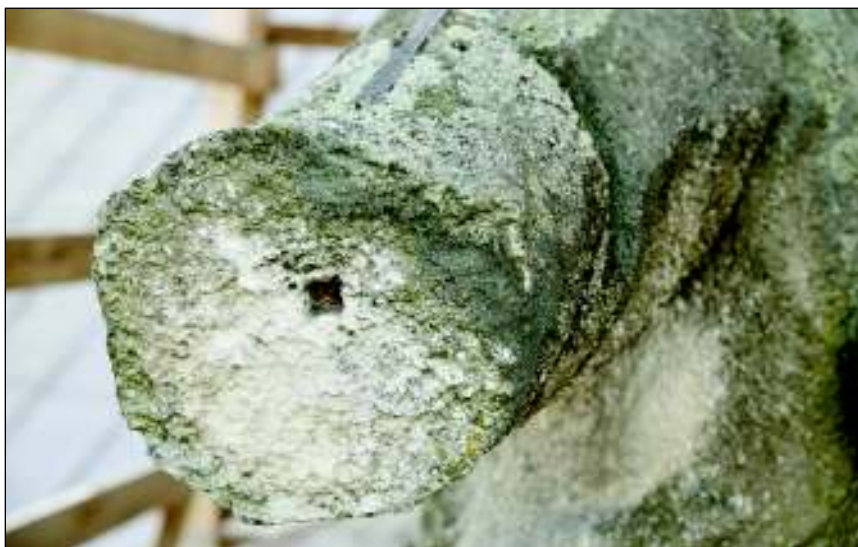
■ Foto 11. Antebraț detașat; în planul îmbinării apare urma ancorei
 ■ Photo 11. Damaged upper arm; the trace of the metal rod

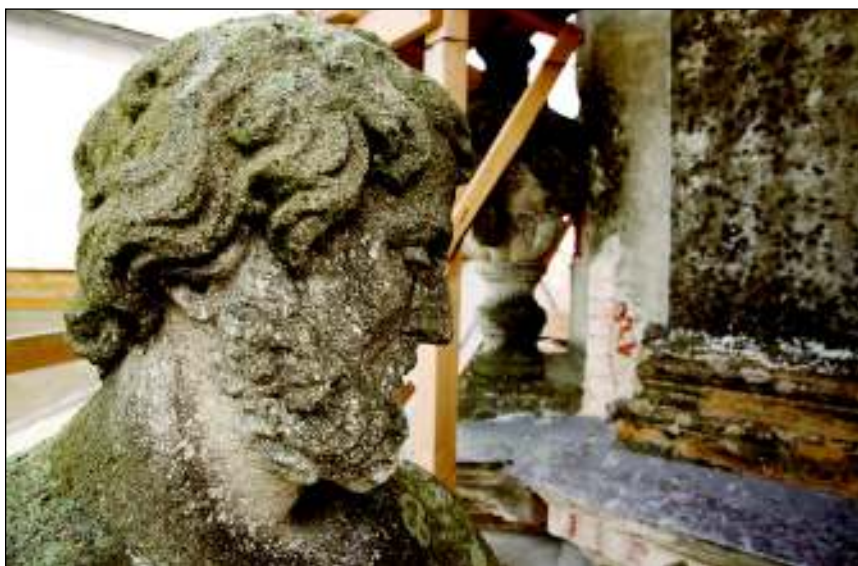
■ Foto 12. Atacul biologic și erodarea suprafețelor este mai pronunțată pe latura nordică
 ■ Photo 12. Biologic attack and erosion of the surfaces is more accentuated on the northern side

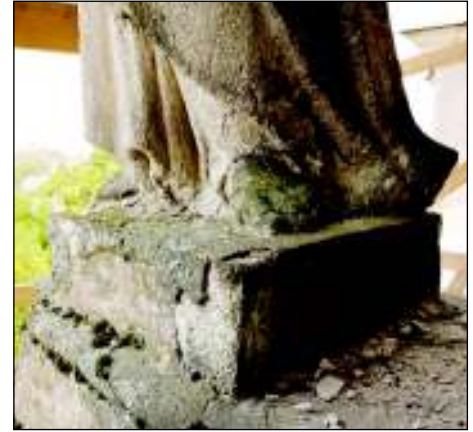
■ The last interventions on the church occurred in 1964. Cement mortar was thus used both for plastering and filling in chipped stone elements. Cement mortar plastering was applied on stone surfaces in various thickness degrees, according to how deep deterioration affected the surface. Such "conservation" attempts were then carried out on all surfaces affected by deterioration.

■ **Foto13.** Plinta a fost reparată cu tencuială neadecvată de ciment
 ■ **Photo 13.** The plinth was repaired with inadequate cement-based plastering

The cement mortar present on the stone surfaces will be removed, as it hinders the restorers' access to the areas to be investigated. Detailed researches will be carried

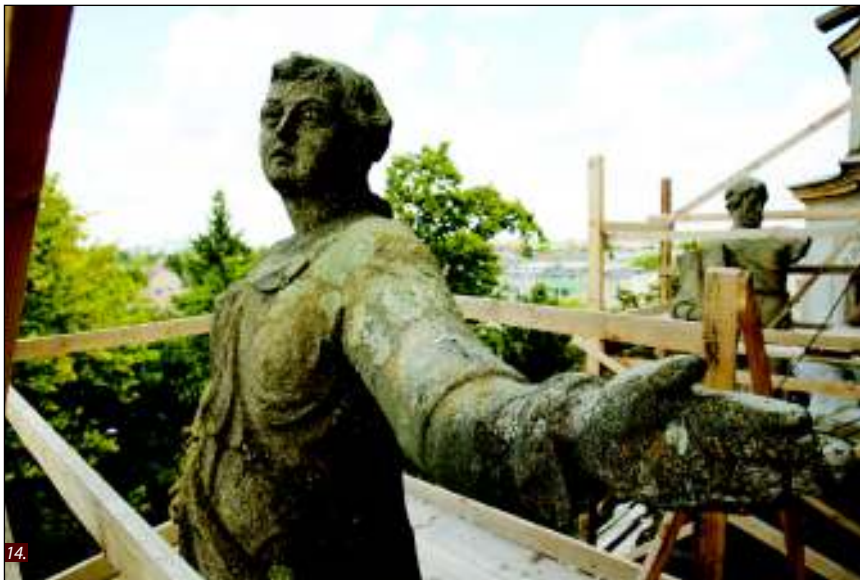
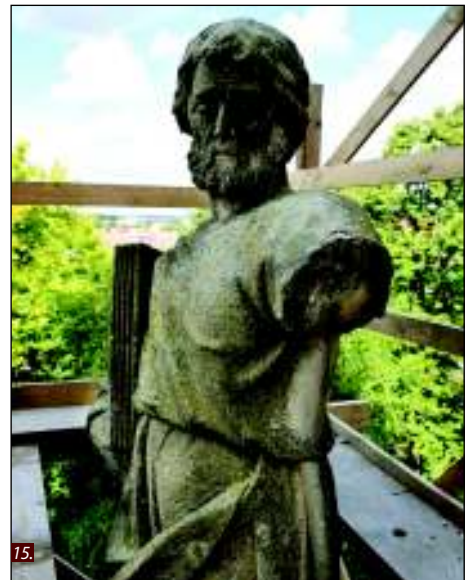
■ **Foto14.** Braț reconstituit din ciment ■ **Foto15.** Statuia lui Sf. Petru cu lipsa brațului; atributul său „cheia Raiului” a fost găsit la bază
 ■ **Photo 14.** Reconstituted arm out of cement mortar ■ **Photo 15.** Statue of Saint Peter with missing arm; his attribute, the “Key of Heaven”, was found at the base

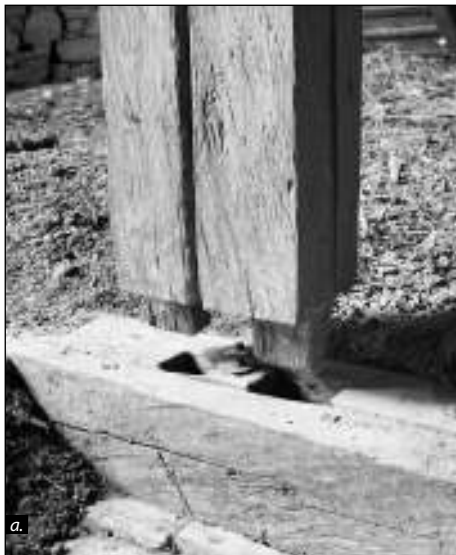
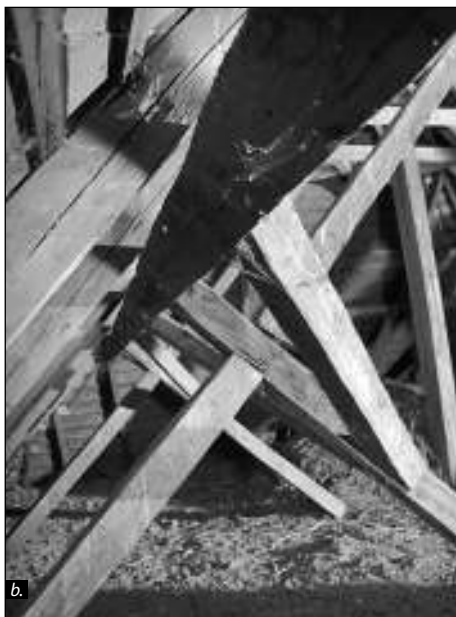
■ **Foto 4.** Insuficiențe de mecanica șarpantei. Probleme de realizare a îmbinărilor, care au condus la: a) deplasare de corp rigid, b) insuficiențe de rezemare. © Adrian TUDOREANU
