Történeti templomterek fűtése

Heating of Historic Churches

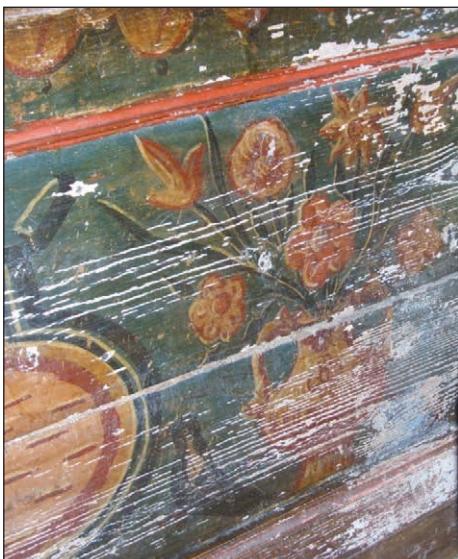
1. kép: A viski/Viskove (Ukrajna) református templom XVIII. századi padmellvédje a kályha közelége miatt károsodott. (Fotó © MIHÁLY Ferenc)

Photo 1. The pew parapet in the Calvinist church of Viskove (Ukraine) dating back to the 18th century was damaged because of the proximity of the stove. (Photo © Ferenc MIHÁLY)

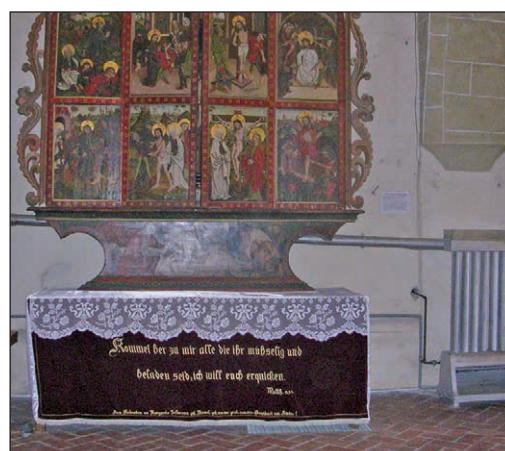
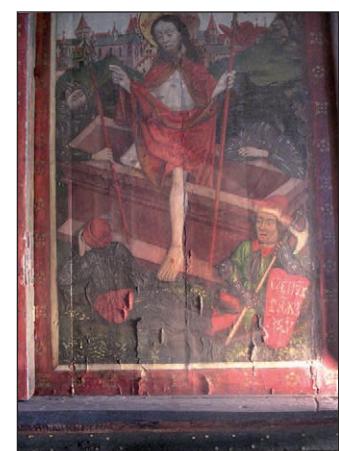
2. kép: A medgyesi/Mediaş (Szeben megye) evangéliikus templomba átköltözött tóbiási (Dupaş, Szeben megye) szárynyasoltár (XV. század vége – XVI. század eleje) és egyik részletén látható károsodások. (Fotó © MIHÁLY Ferenc)

Photo 2. The Polyptych moved to the Lutheran church in Mediaş (Sibiu County) from Dupuş (Sibiu County) (end of the 15th century and beginning of the 16th century) and its detail with decays. (Photo © Ferenc MIHÁLY)

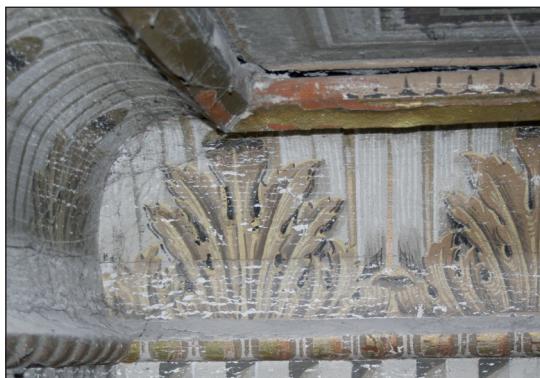
■ **3. kép:** A nagyszebeni/Sibiu (Szeben megye) ferences zárda dísztermének díszítő festésének károsodása (Fotó © KISS Lóránd)

■ **Photo 3.** The damaged ornamental paintings of the assembly hall in the Franciscan convent from Sibiu (Sibiu County). (Photo © Lóránd KISS)

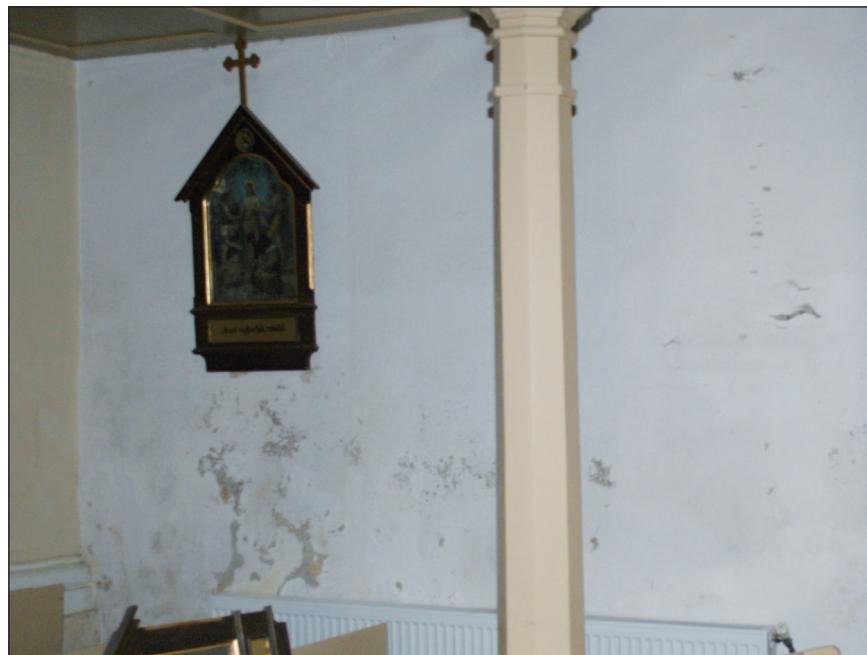
■ **4. kép:** Sókivirágzások és pergő festés/vakolat a csíkszentgyörgyi/Ciucsântgiorgiu (Hargita megye) katolikus templom fűtőteste fölött.

■ **Photo 4.** Salt efflorescence and peeled off paint/plaster above the radiator in the Catholic church from Ciucsântgiorgiu (Hargita County)

The stability of the temperature on the surface of the objects and walls is also important, which alongside with the relative humidity of the air influence the humidity content of the objects. Direct heat radiation results in the heating and drying of the walls, which could lead to the occurrence of salt efflorescence and peeling on the surface of the walls or murals. (Photo 4)

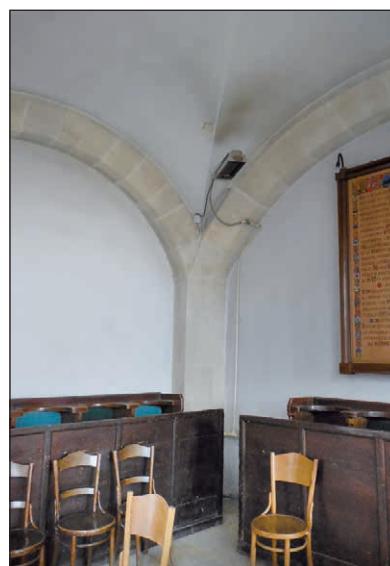
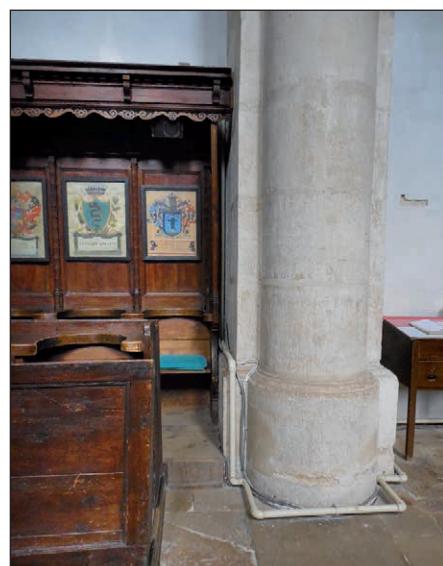
■ **5. kép:** A kolozsvári/Cluj-Napoca (Kolozs megye) Farkas utcai református templom egyik gázmelegítésű IR sugárzója fölött látható feketedés és a szükséges gázvezeték látványa.

Besides influencing the values of environmental parameters, the heating system also accentuates the air movement inside the church. It causes the impurities to settle quicker on the walls and the surface of the objects. Black spots may mostly occur above heating elements. (Photo 5)

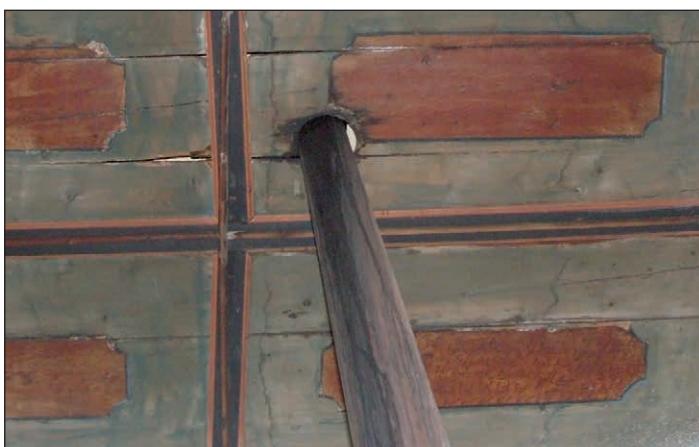
■ **6. kép:** A magyarhermányi/Herculian (Kovászna megye) református templomban a kályhacsövet a XVIII. század második felében készült kazettás mennyezeten keresztül vezették ki. (Fotó © MIHÁLY Ferenc).

plasztikus díszítőelemeken, falképeken, díszítőfestésen átvezetett, akár ezekhez rögzített kábelekkel, csövekkel, átfűrt, átvágott történeti templombútorzattal vagy kazettás mennyezettel (6. kép).

Last but not least we must mention the very so often serious damages caused recklessly during the heating system installation: we often encounter cables, pipes taken through statuesque adorments, murals, ornamental paintings or fitted to them, drilled or cut across historic church furniture or coffered ceilings. (Photo 6)

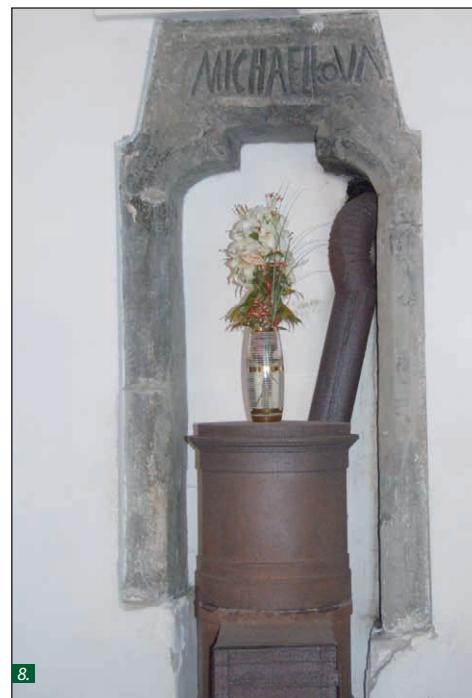
8.

■ **8. kép:** A homoródklándi/Ocland (Hargita megye) unitárius templom kályhájának látványa. (Fotó © MIHÁLY Ferenc) ■ **Photo 8.** The stove in the Unitarian church in Ocland (Harghita County). (Photo © Ferenc MIHÁLY) ■ **9. kép:** Az eceli/Atel (Szeben megye) evangélilikus templom két vaskályhájának egyike: a kályhacső történeti díszítőelemeket vág át és megengedhetetlen módon zavarja a teljes templomter látványát. ■ **Photo 9.** One of the two iron stoves in the Lutheran church in Atel (Sibiu County): the chimney pipe passes through historical ornamental elements and inadmissibly disturbs the overall picture of the church.

- Photo 8.** The stove in the Unitarian church of Ocland (Harghita County). (Photo © Ferenc MIHÁLY)
- Photo 9.** One of the two iron stoves in the Lutheran church of Ațel (Sibiu County): the chimney pipe passes through historical ornamental elements and inadmissibly disturbs the overall picture of the church.

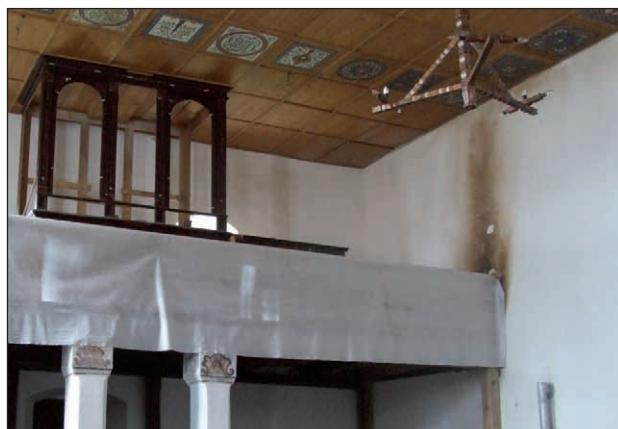
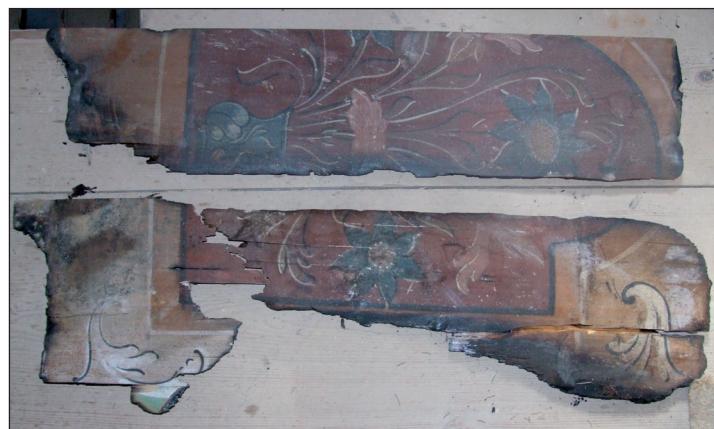
■ **10. kép:** Az illyefalvi/Ilieni (Kovászna megye) református templom túlfűtött kályhája miatt kigyült a templom karzata. A tűz szerencsére lefulladt, de a XVIII. századi karzatmellvéd pár kazettája visszafordíthatatlanul károsodott. (Fotó © MIHÁLY Ferenc)

■ **Photo 10.** The loft of the Calvinist church from Ilieni (Covasna County) caught fire due to the overheated stove in the church. Fortunately the fire did not spread but some coffers of the 18th century loft balustrade were irredeemably damaged. (Photo © Ferenc MIHÁLY)

fire and thus the objects are not only prone to the damages cause by RH variations and impurities but also to a complete destruction in a fire (Photo 10).

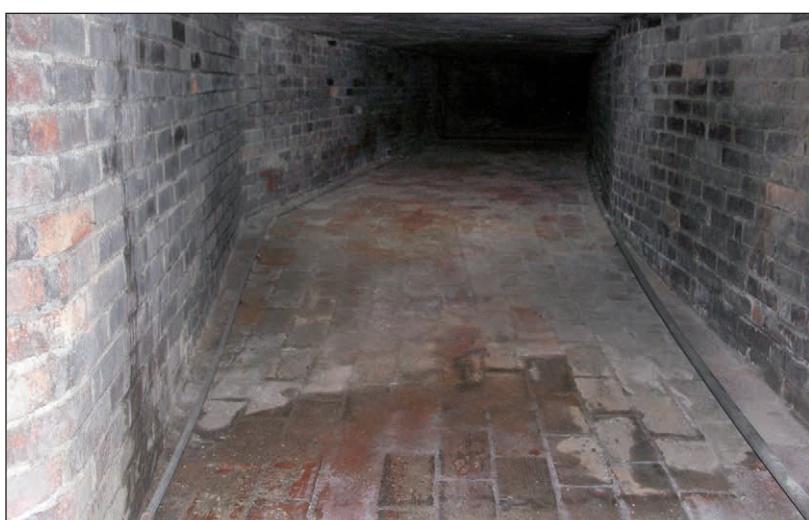
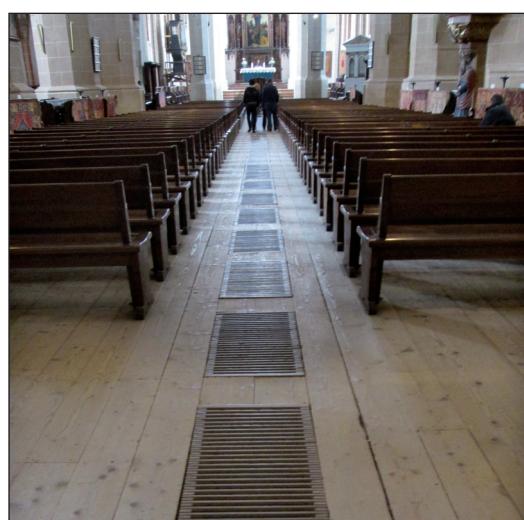
■ **11. kép:** A brassói/Brașov (Brassó megye) Fekete templom meleg levegőt befújó rendszere: a földalatti légcatorna részlete és a templom padlójában levő rácsozat, melyen át a meleg levegő a templomterébe jut. (Fotó © Brassói szász evangélikus egyházközség)

In the case of *warm air heating systems*, hot air enters the church via the grid placed in the walls or the floor (Photo 11), sometimes the generator itself is placed in the church, which does not look appropriate (Photo 12). Heating is occasional, less expensive but is suitable neither for the churchgoers nor the objects. It is noisy, draughty and it is not really efficient because hot air is directed upwards by the laws of physics. On top it damages the ceiling, the organ and other objects due to the high RH variations and it also significantly increases the settling of impurities.⁸ The movement of the air causes drying and subsequently salt efflorescence in murals.

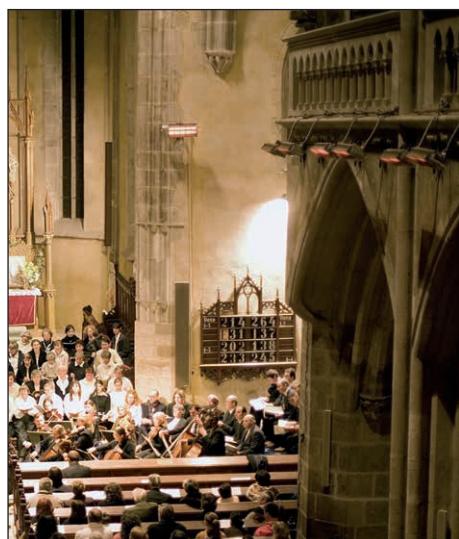
■ 13. kép: A nagyszebeni/Sibiu (Szeben megye) evangéliikus főtemplomba 2006-ban beszerelt gázüzemeltetésű IR hőszugárzók. (Fotó © Nagyszebeni evangéliikus egyházközség)

■ Photo 13. The gas-operated IR radiators were mounted in the central Lutheran church from Sibiu (Sibiu County) in 2006. (Photo © Lutheran Parish from Sibiu)

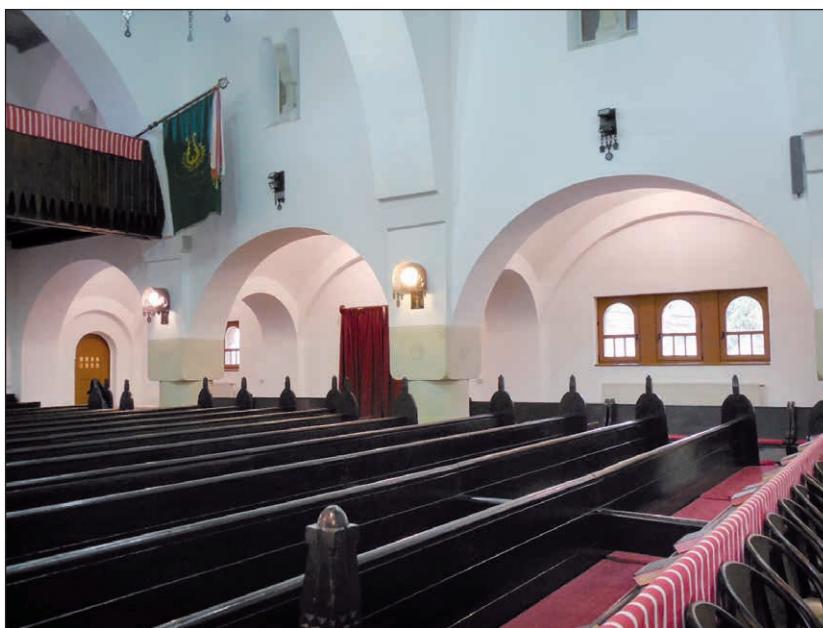
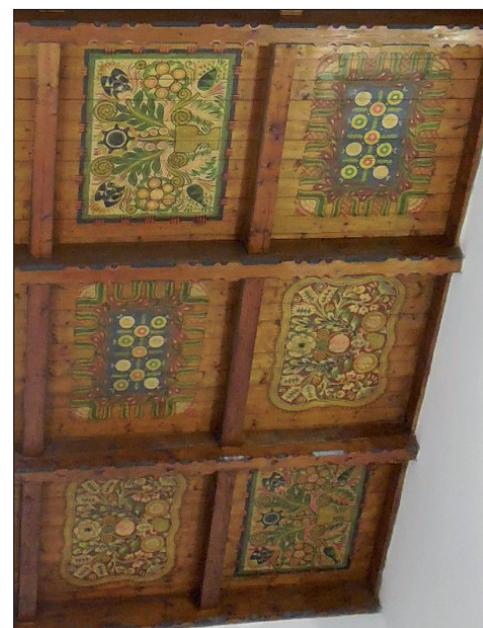
■ 14. kép: A kolozsvári/Cluj-Napoca (Kolozs megye) Kakasos református templom nemrég felújított központi fűtésének látványa és a templom kazettás mennyezetének részlete.

They can be operated permanently and/or occasionally. In case they are constantly operated, they can dangerously decrease the RH in the church, especially in cold climate conditions damaging thus the heritage objects. A suitable solution would be their operation at moderate temperature settings (Photo 14).

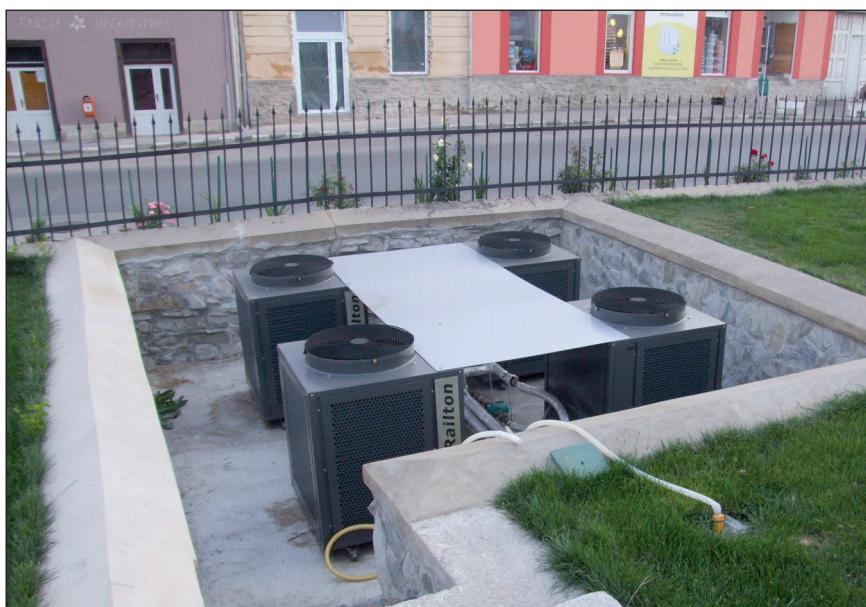
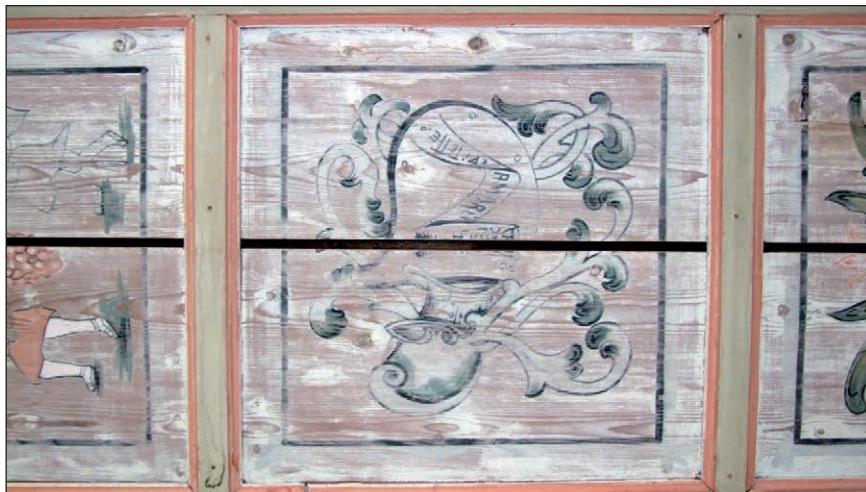
■ 15. kép: A krasznai/Crasna (Szilágy megye) református templomba a közelmúltban beszerelt padlófűtés gépépítének látványa és az új fűtés okozta repedés a templom kazettás mennyezetén..

■ Photo 15. The aspect of the powering system of the recently installed under floor heating in the Calvinist church from Crasna (Sălaj County) and the crack in the painted coffered ceiling of the church caused by the new heating system.

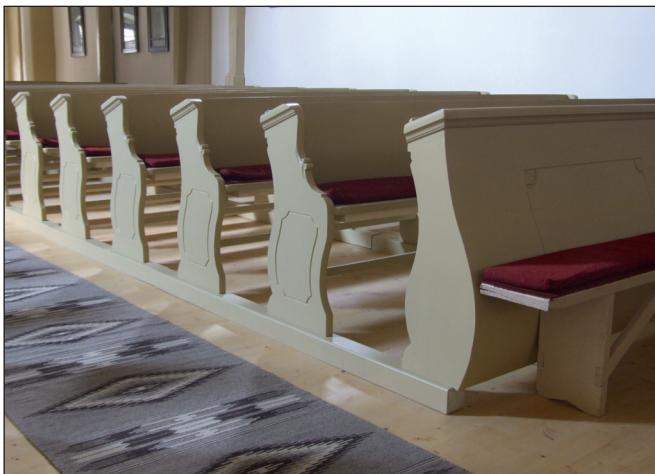
16. kép: Csíkkarcfalván/Cârța (Hargita megye), a katolikus templomba, a nemrég befejezett teljes felújítás alkalmával vezették be a képen látható padfűtést (Fotó © MIHÁLY Ferenc).

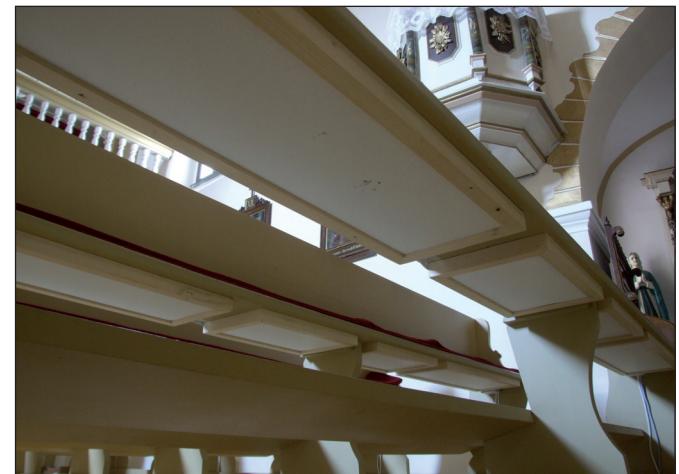
Photo 16. The pew heating shown in the photo has recently been installed in the Catholic church in Cârța (Harghita County), on the occasion of the recent conservation works. (Photo © Ferenc MIHÁLY)

Pew heating is strictly aimed at keeping the people sitting in the pews warm, it almost does not influence inner temperature at all and its sight is not disturbing. The heating elements are mounted on every pew (the pews must be fastened to the floor). Although the system and the installation are relatively expensive, its operation is less expensive, especially if it is possible to partially use it, i.e. to heat the occupied rows selectively. Since it warms up the feet and the back, pew heating offers a pleasant thermal convenience. There are several known practical solutions: hot air blowers, IR radiators (Photo 16) and the hot water-filled heaters also have pew heating variants (Photo 17).

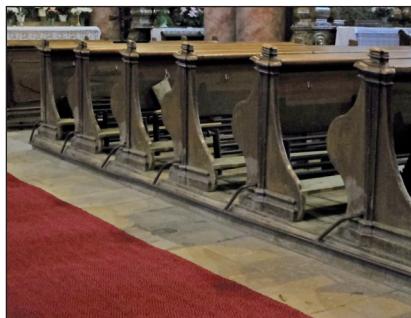
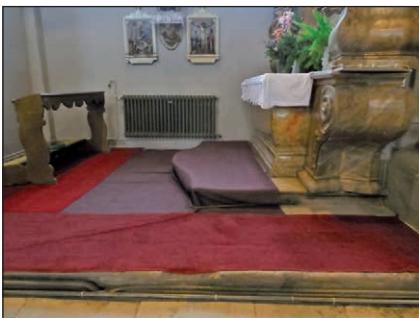
■ **17. kép:** A Nagyszeben/Sibiu (Szeben megye) központjában levő római katolikus templom meleg vizes padfűtése és egy a mellékoltárakban elhelyezett fűtőtestek közül.

■ **Photo 17.** Hot-water operated pew heating in the Catholic church of downtown Sibiu (Sibiu County) and one of the radiators placed in the side altars.

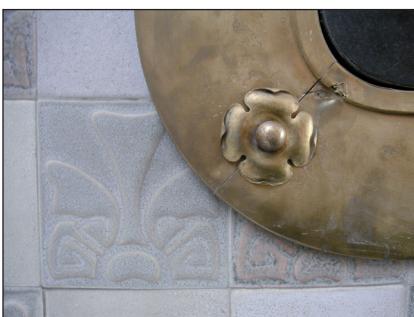
■ 3. kép: A felújított Zsolnay kerámák
■ Photo 3. The restored Zsolnay tiles

Among the interior decorations of the building, the substitution of the tiles fabricated in the Zsolnay Factory in Pécs proved to be the most difficult task, since the chemical composition of the special, reactive glaze was not available. The main point in this glazing method is that the ceramics receive their final colour unique in the case of each tile, their peculiar, spotty pattern, when different glaze layers applied in several phases go through a chemical reaction during firing. The colour and the pattern depend on the duration and temperature of firing as well; originally, in different parts of the kiln heated with coal, different patterns and colours took shape. The modern kilns, in which a built-in system ensures uniform temperature, are evidently unsuitable for this task. Thus the needed tiles could be manufactured only with small-scale fabrication methods. We achieved this thanks to the joint work of the small studios. More than a thousand test firings were needed in order to set the final colours consisting of some fifty shades.

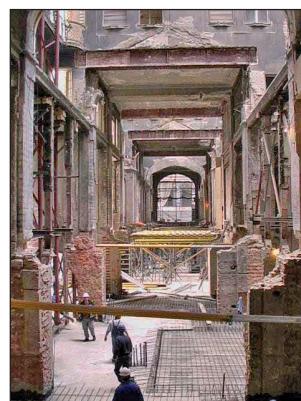
■ 11. kép: A pincefödém kibontása utáni állapot
■ Photo 11. The cellar slab after opening up

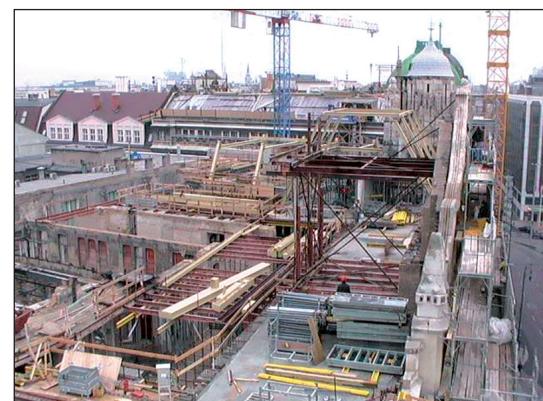
■ 12. kép: A tető építése
■ Photo 12. Construction of the roof

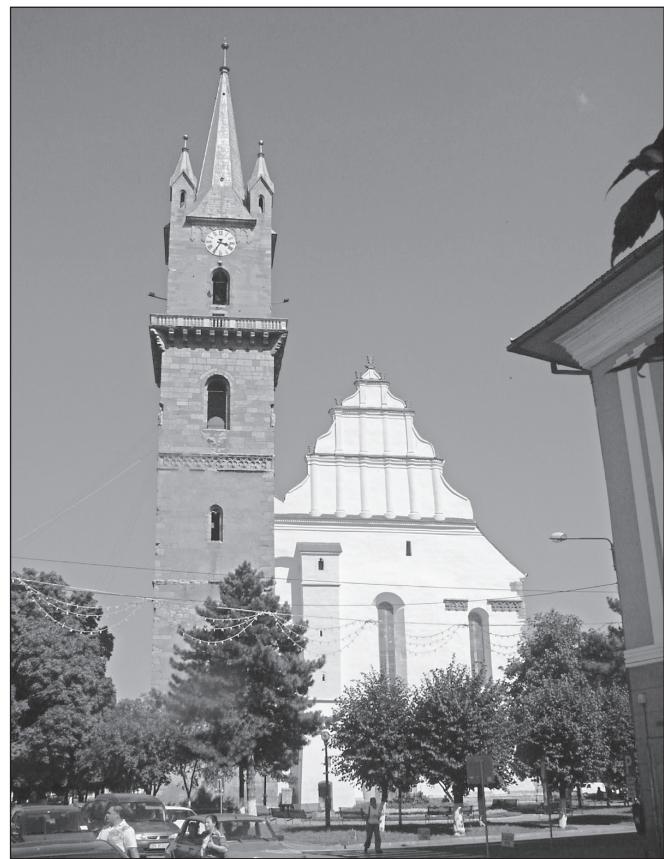
■ **Foto 2.** Structuri portante istorice: Biserica Evangelică din Bistrița (jud. Bistrița-Năsăud)

■ **Photo 2.** Historic load-bearing structures: Lutheran Church in Bistrița (Bistrița-Năsăud County)

We believe that we may consider as exceptional the interventions settling insufficiencies that have persisted for centuries. For instance, the western elevation of the Lutheran Church in Bistrița had been affected by cracks for centuries (ever since the 18th century), caused by the horizontal components that were not taken over at the level of the roof structure tie-beam, and of the vault springing adjacent to the western elevation.

The absence of a tie-beam – common rafter joint at the level of the tower on the first four trusses allowed the transmission of the horizontal component at tie-beam level to the tower (that took over this component without consequences), and the southern longitudinal wall, which drew the southern part of the western elevation by its deformation, generated and maintained a crack on the western elevation of the church aisle. Similarly, the horizontal components at the level of the vault springers and of the gallery had an impact on the southern wall and increased the cracks caused by the roof structure. By fixing the tie-beams of the trusses against the tower, and by introducing metallic rods at the level of the vault springers, the intervention may be considered exceptional, as no crack can be seen any more on the western elevation of the church aisle since 1995 (archive pictures: Photos 13 and 14 and picture after the intervention: Photo 2).

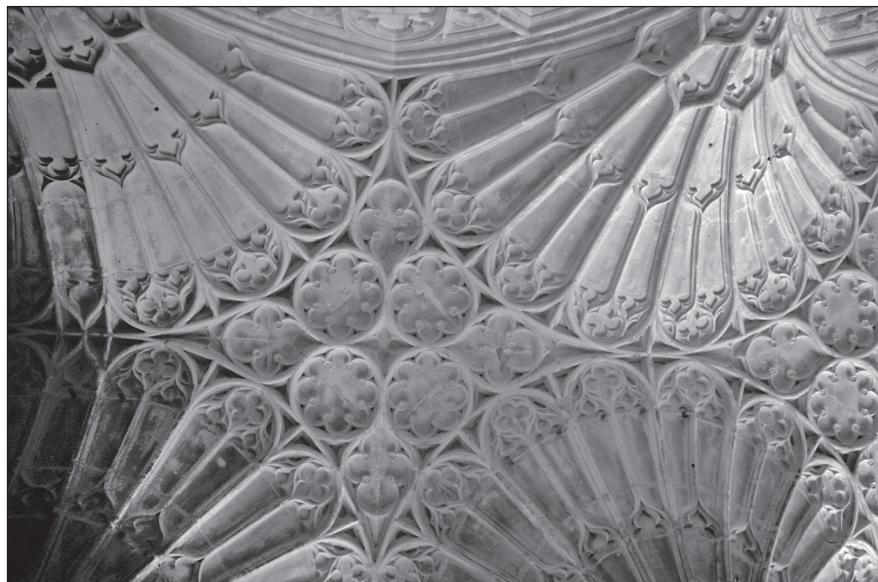
■ **Foto 4.** Subansambluri de structură portantă istorică: planșeu istoric boltit, realizat din piatră sculptată

■ **Photo 4.** Historic load-bearing structure sub-units: vaulted historic slab made up of carved stone

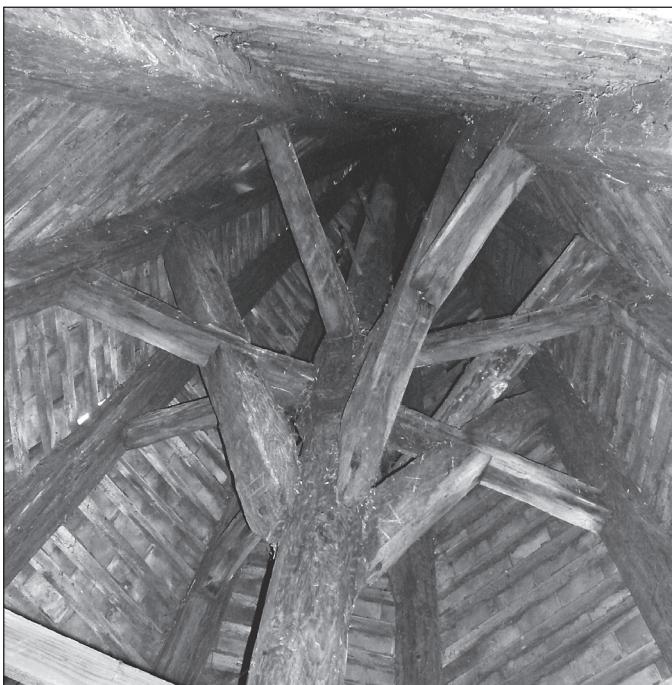
■ **Foto 5.** Elemente de structură portantă istorică: catarg la o șarpantă spațială cu caracter gotic
■ **Photo 5.** Historic load-bearing structure elements: king post of a Gothic spatial roof structure

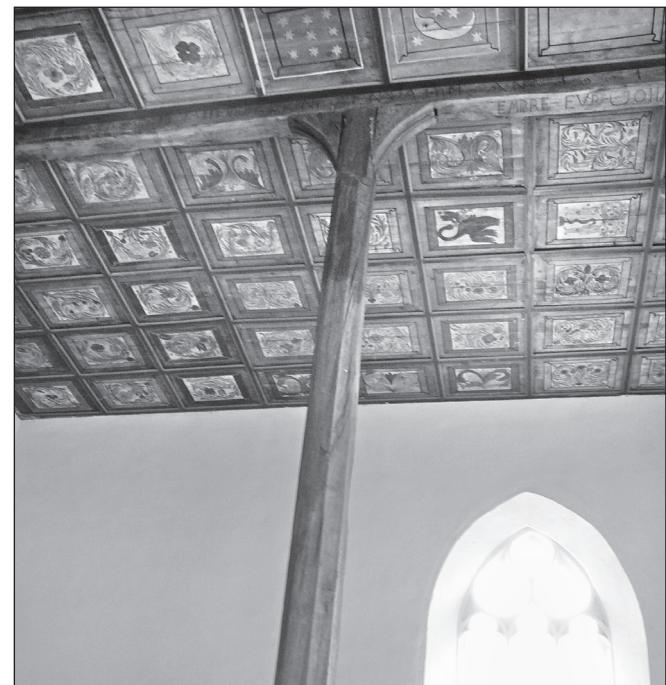
■ **Foto 6.** Elemente de structură portantă istorică: stâlp din lemn, parte din sistemul de susținere a tavanului casetat
■ **Photo 6.** Historic load-bearing structure elements: timber pillar, part of the supporting system for the coffered ceiling

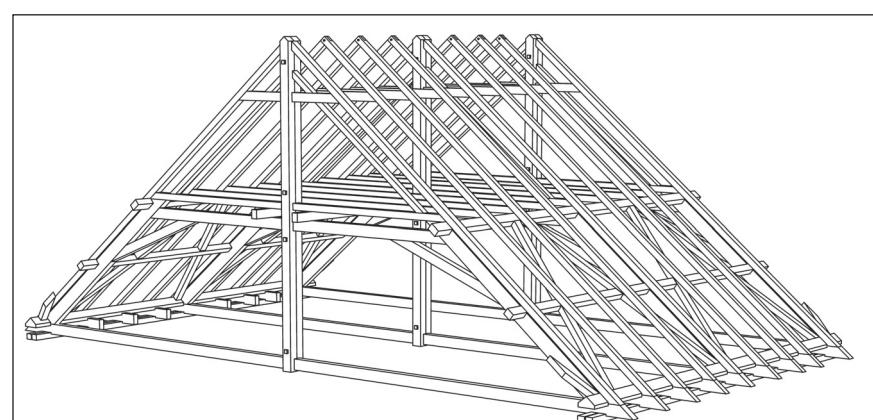
■ **Fig. 1.** Concepție de excepție la un subansamblu de structură portantă: șarpanta barocă – dispozitivul de tensionare, respectiv sistemul planar longitudinal de rigidizare
■ **Figure 1.** Exceptional concept of a load-bearing sub-unit: baroque roof structure – the straining trusses and the longitudinal roof bracing frame

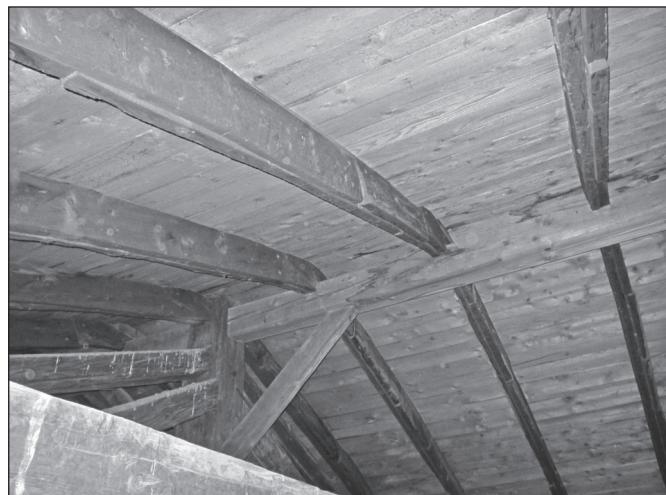
■ **Foto 7.** Tehnologii de excepție la subansambluri de structură portantă istorică: șarpanta Bisericii Ortodoxe din Lugoj, cu căpriori alcătuși din perechi de dulapi

■ **Photo 7.** Exceptional technologies of historic load-bearing structure sub-units: roof structure of the Orthodox Church in Lugoj, with common rafters made up of plank pairs

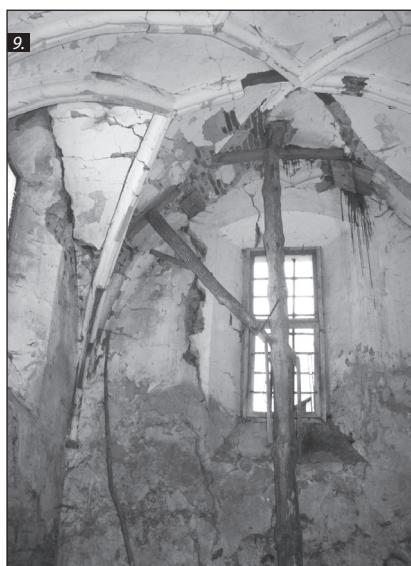
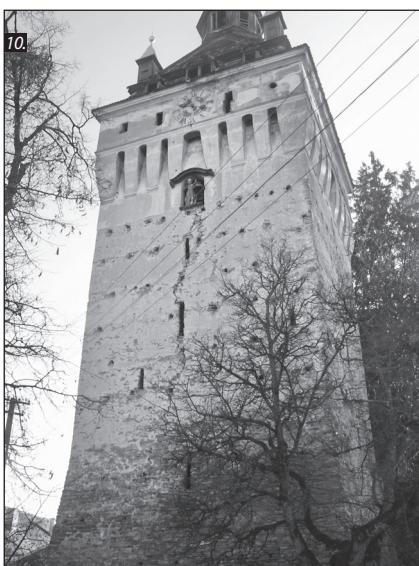
■ Foto 9. Acțiuni de excepție provocând insuficiențe provenite din: cursarea lentă a versantului la Biserica Evanghelică din Copșa Mare ■ Foto 10. Acțiuni de excepție provocând insuficiențe provenite din: activitate seismică la turnul Bisericii Evanghelice din Saschiz

■ Photo 9. Exceptional actions causing insufficiencies resulted from: the slow sliding of the slope in the case of the Lutheran Church in Copșa Mare ■ Photo 10. Exceptional actions causing insufficiencies resulted from: seismic action in the case of the tower of the Lutheran Church in Saschiz

Rarely occurring actions may be considered exceptional (e.g. seismic actions or slope stability loss), but also long lasting actions, such as the slow sliding of slopes (a few centimeters sliding in a century) – the Lutheran Church in Copsă Mare or the Orthodox Church in Corvinești, which has been cracked for centuries, because of the slow sliding of the slope on which it is built, the tower of the Lutheran Church in Saschiz has vertical cracks caused by seismic actions on the neutral axis, where the section is weakened by holes and the sliding is maximum.

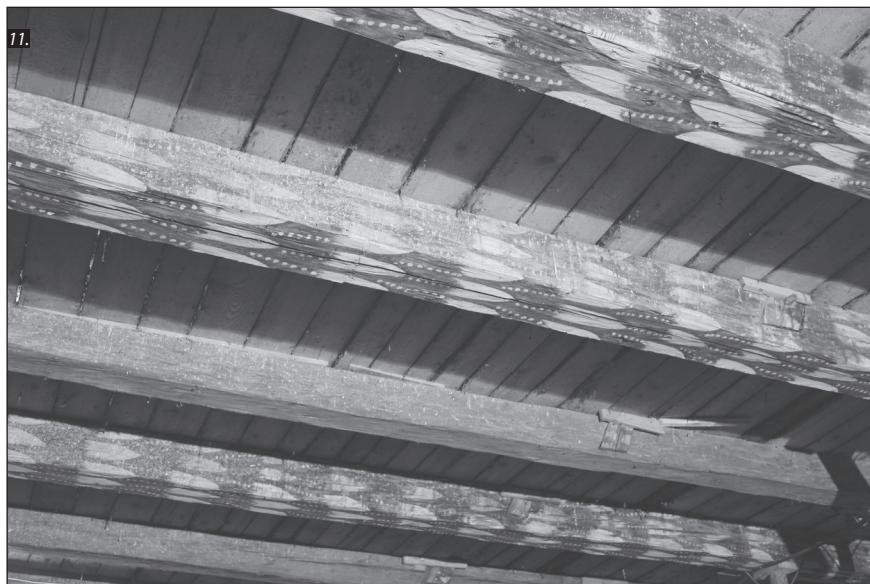
■ Foto 11. Structuri portante istorice cu structuri purtate de excepție: corzile pictate ale șarpantei Bisericii Reformate din Dej ■ Foto 12. Structuri portante istorice cu structuri purtate de excepție: subansambluri din lemn pictat la Biserica Ortodoxă din Desești

■ Photo 11. Historic load-bearing structures with exceptional non-bearing structures: painted tie-beams of the roof structure of the Reformed Church in Dej ■ Photo 12. Historic load-bearing structures with exceptional non-bearing structures: painted wood sub-units of the Orthodox Church in Desești

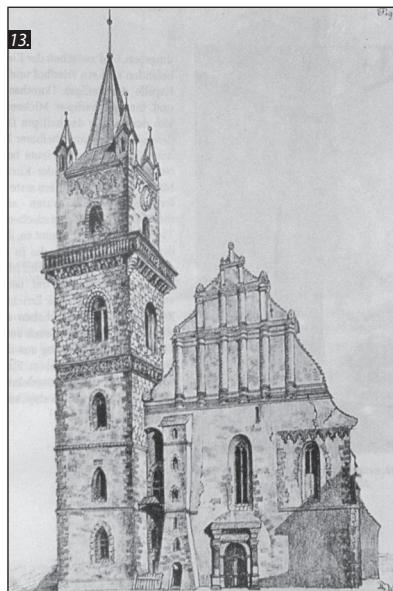
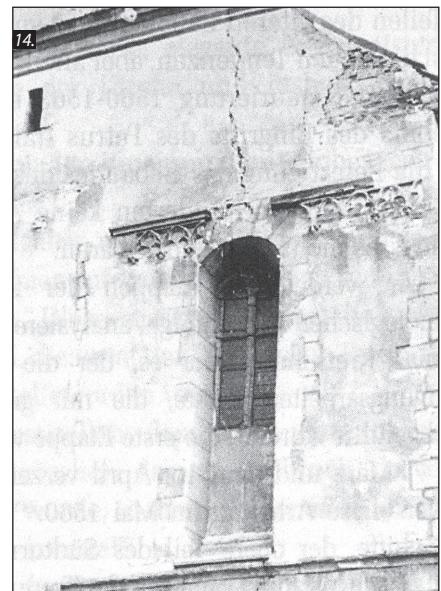
■ Foto 13. Intervenție de excepție la Biserica Evanghelică din Bistrița la insuficiență care persistă de secole: fațada vestică cu zidăria crăpată ■ Foto 14. Intervenție de excepție la Biserica Evanghelică din Bistrița la insuficiență care persistă de secole: detaliu fațada vestică cu zidăria crăpată la baza frontonului, în dreptul ferestrei sudice

■ Photo 13. Exceptional intervention on the Lutheran Church in Bistrița for an insufficiency that had persisted for centuries: western elevation with cracked masonry ■ Photo 14. Exceptional intervention on the Lutheran Church in Bistrița for an insufficiency that had persisted for centuries: detail on the western elevation with cracked masonry at the basis of the gable, at the level of the southern window

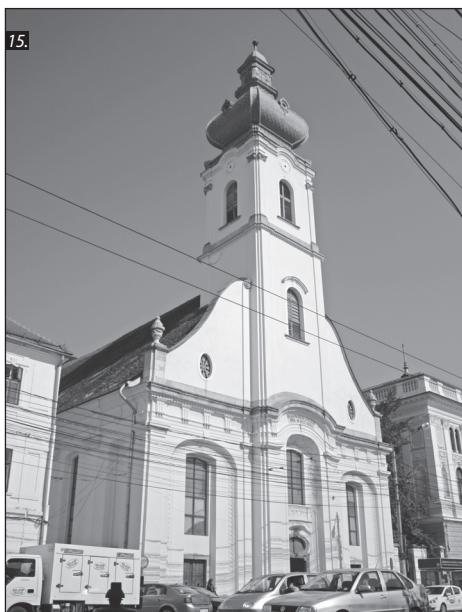
■ Foto 15. Biserica unitariană din Cluj-Napoca, fațada vestică ■ Foto 16. Intervenție de excepție la Biserica Unitariană din Cluj-Napoca la insuficiență care persistă de secole: tiranți metalici la nivelul nașterii boltjilor de mare deschidere

■ Photo 15. Unitarian Church from Cluj-Napoca, western elevation ■ Photo 16. Exceptional intervention on the Unitarian Church in Cluj for an insufficiency that had persisted for centuries: metallic rods at the level of the vaults with wide opening

Biserica Unitariană din Cluj s-a realizat la sfârșitul secolului al XVIII-lea cu pereți portanți de rigiditate insuficientă față de componenta orizontală a boltii de acoperiș, dată de o deschidere prea mare, față de rigiditatea pereților portanți dispuși pe perimetru bisericii.

În cei 200 de ani de existență, bolta de acoperiș a fost mereu crăpată, intervențiile anterioare – inclusiv realizarea unor contraforți la biserică barocă, proptirea bisericii de o casă vecină la nivel de acoperiș, înzidirea unor goluri în pereții portanți de susținere – nu au asigurat rigiditatea suficientă. Intervenția de excepție din anii '90, constând în montarea unor tiranți metalici la nivelul nașterii boltelor, a permis preluarea componentelor orizontale la nivel de acoperiș, biserică fiind de atunci fără crăpături la nivel de boltă acoperiș.

During its 200 years of existence, the roof vault had always been cracked, and the previous interventions – including the building of buttresses on the Baroque church, the propping of the church against a neighbouring house at the level of the roof, the bricking up of certain holes in the supporting load-bearing walls – could not ensure sufficient rigidity. The exceptional intervention from the 90s, consisting in the fitting in of metallic rods at the level of the vault springers, enabled the taking over of the horizontal components at the level of the roof, and no cracks could be seen anymore at the level of the roof vault ever since.

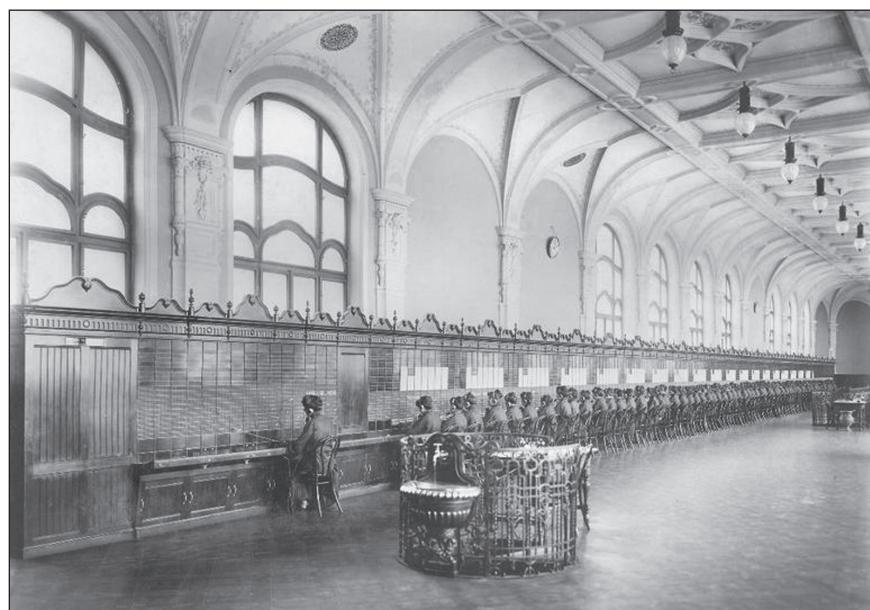
■ Foto 3. Harmadik emeleti nagyterem, eredetileg kézi kapcsolóterem volt

■ Photo 3. The hall on the 3rd floor, originally it hosted the manual switchboards

The premises upstairs were used almost exclusively as offices during the last decades. This function would not be altered. What is changed though is that we completed the existing two staircases and a subsequently added narrow elevator with two new vertical shafts and an elevator. Thus we eliminated hundred meters long corridors, and the building was provided with four elevators and four staircases. The new shafts were placed within the two towers originally destined to receive the aerial cables. At the top of the towers the exterior air-conditioners were installed, concealed by parapets as much as possible.

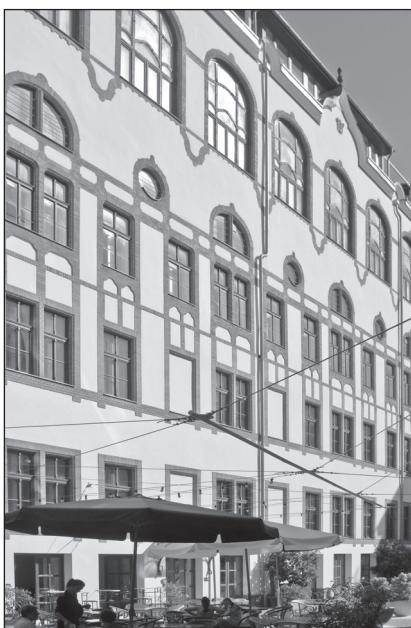
■ Foto 5. A telefonközpont udvari homlokzata a felújítás után

■ Photo 5. The courtyard elevation of the Telephone Central Office, after the conservation works

A homlokzatok különböző mértékben alakultak át az idők során, majd alakultak vissza is. Az utcaiak csak erodálódtak, elkoszosodtak, az udvarit viszont alaposan átépítették. Az eredeti ablakokat több átépítés alkalmával nagyrészt megszüntették, helyettük hatalmas összefüggő üvegtéglás felületek keletkeztek. Felújításunk során a homlokzatok az eredeti vagy ahhoz nagyon közeli állapotba kerültek.

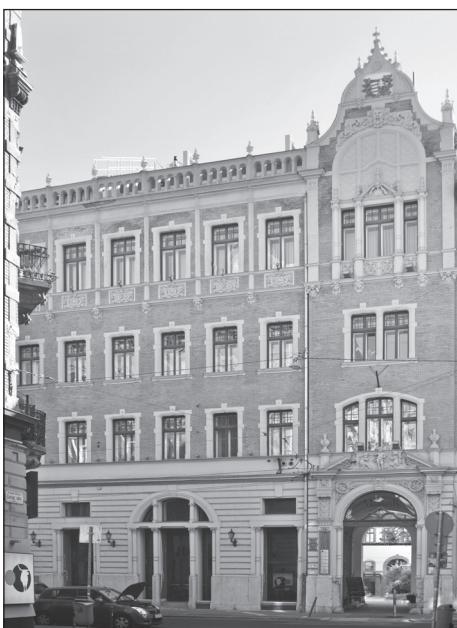
■ Foto 6. A telefonközpont főhomlokzata a felújítás után

■ Photo 6. The main façade of the Telephone Central Office, after the conservation works

The main façade giving to the Nagymező Street received the symmetric pair of the gateway on the left side, the entrance to the parking garage. The gateway was built following the existing gate's model. The ground-floor windows lost their breast, and turned into portals. They had to wait for a few years that a shop or restaurant would be opened behind them. During the restoration of the windows on the 1st floor, the exterior casements were preserved, and heat-insulating glasses were installed only in the interior. The brick masonry was repaired and supplemented, then cleaned and provided with a hydrophobic protection, the plaster surfaces were repaired and painted.

A Nagymező utcai főhomlokzat baloldalon megkapta a kapualj szimmetrikus társát, a parkolóház bejáratát. A kapu kialakítása a meglévő mintájára készült. A földszinti ablakok elvesztették a parapetüket, portálokká váltak. Pár évig várták, hogy mögöttük üzlet vagy vendéglátóhely nyíljék. Az emeletek ablakait úgy alakították ki, hogy a külső szárnyaik az eredetiek maradtak, csak a belső rétegek a hőszigetelők. A téglafelületek javítás, pótítás után tisztítást, hidrofób védelmet kaptak, a vakolt mezők javítást és színezést.

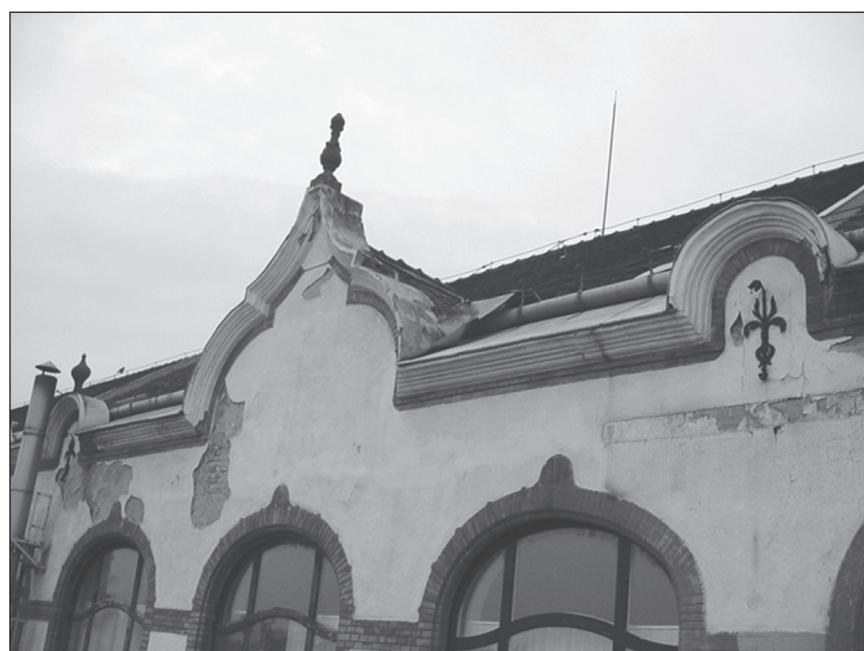
■ Foto 8. Részlet az udvari homlokzatról
■ Photo 8. Detail of the courtyard elevation

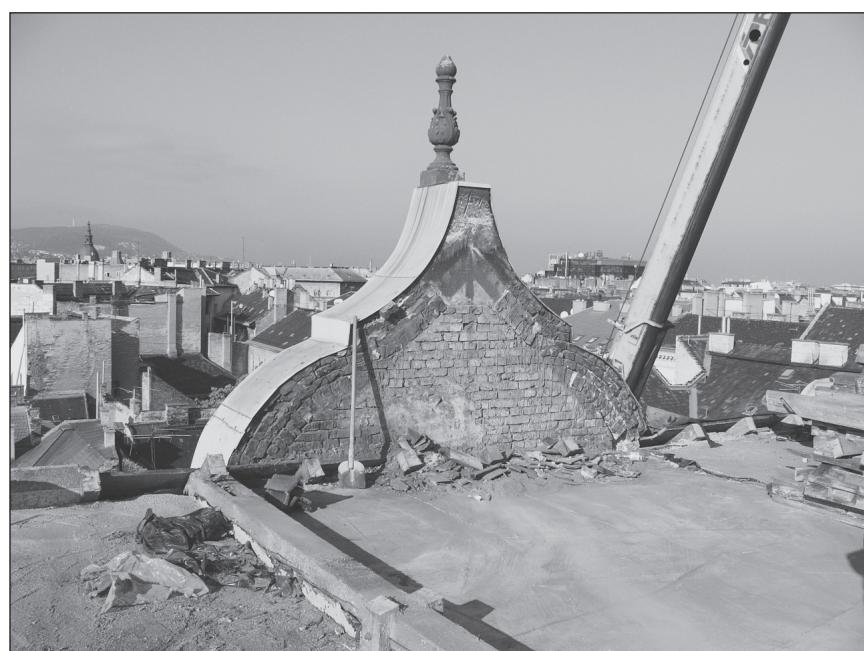
■ Foto 9. Felújítási munkálatok a tetőn
■ Photo 9. Conservation works on the roof

Az átépítés során a tető így szabad vadászterületnek tekintettük. A padlásterek, búvóterek, gépterek, antennaalapozások és kábfelfolyosók helyett a harmonikus tetőidomok alá lakásokat építettünk. A tetőszinti lakásokhoz teraszot alakítottunk ki. Az utcák felőli teraszokat a tetőkba mélyítettük. Az áttört párkányok külső látványukat eltakarják, de mégis lakkatóvá teszik a teraszokat. Az udvar felé néző teraszokat – amikről az egész várost körbe lehet tekinteni – a belső homlokzat pártázata rejti diszkréten.

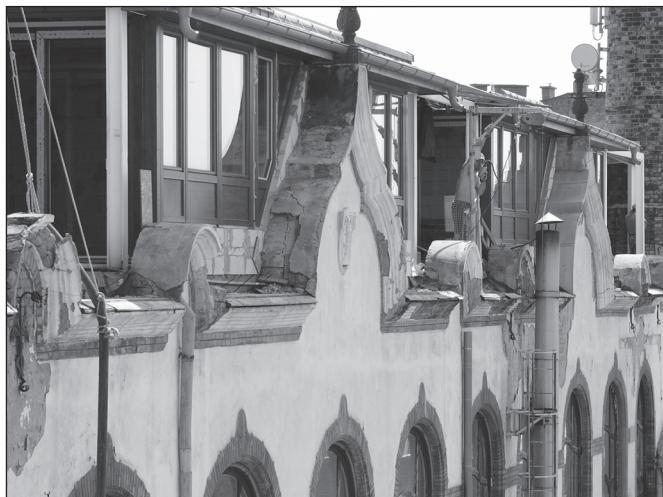
■ Foto 10. A tetőszinti lakások kialakítása
■ Photo 10. Building apartments at the loft level

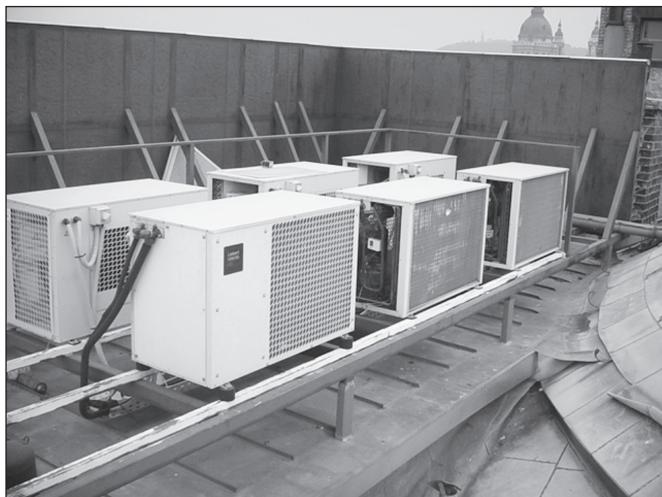
■ Foto 11. A mellvédfalak mögé helyezett kültéri klímagépek
■ Photo 11. Exterior air-conditioners concealed by parapets
