A beszercei evangélikus templom

A beszercei evangélikus templom építéstörténete

The Lutheran Church in Bistrița

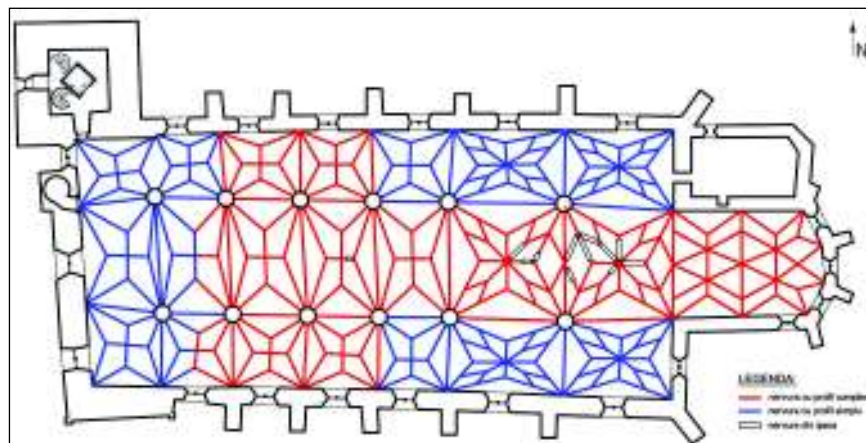
■ 1. ábra: Bordatípusok eloszlása. © UTILITAS
 ■ Figure 1. The distribution of rib types. © UTILITAS

A főhajó boltozatának 2 hosszanti repedésén kívül – amelyet a támaszok elmozdulása és elfordulása okozott – az állványról láthatóvá váltak a boltmezők közti technológiai repedések, továbbá a bordák és boltmezők közti repedések. A falkutatás során kiderült, hogy két típusú téglaidomból falazták a bordákat, a hosszabbikat (nyaktaggal rendelkezőt) beleszórták a boltozatba, a rövidebbet pedig csak habarccsal a boltozathoz és a szomszédos idomtéglaéhoz illesztették. Bordán belül változó a nyaktagos idomtégla gyakorisága, bizonyos szakaszokon minden harmadik, negyedik, más-hol viszont csak minden kilencedik volt beleszóve a boltozatba. Ott, ahol a vakolatban repedés jelentkezett, a vakolat eltávolítása után kiderült, hogy a beszórt téglaidom nyaka letört, és ezért mozdult ki eredeti helyéről az általa megtartott bordaszakasz.

Az idomtégla két különböző tagolással készültek. Az ezekből készült egyszerűbb és összetettebb kiképzésű bordák eloszlása az 1. ábrán tekinthető meg. Kékkel az egyszerű, pirossal az összetett tagolású bordákat, fekete kerettel az 1926-os helyreállításkor beépített gipszbordaelemeket jelöltük. Az egyszerű tagolású nyaktags nélküli téglaidom mérete 18,6x14,3x4 cm, az egyszerű tagolású nyaktagos 27,6x14,3x4 cm, az összetett tagolású nyaktags nélküli 21,4x14,3x4 cm, az összetett tagolású nyaktagos 30,2x14,3x4 cm. A hajó csillagboltozatán és a szentély hálóboltozatán összesen 1482 méternyi borda található, melyből 753 méter összetett tagolású és 729 méter egyszerű tagolású. A bordák megerősítése annak függvényében zajlott, hogy milyen mértékben mozdultak ki eredeti helyükről. Ha nagy volt az eltávolodás, akkor kibontották az elemeket és visszaépítették őket, ha pedig kisebb volt az elmozdulás, akkor tixotróp, kétkomponensű, epoxigyanta és speciális töltőanyag keverékén alapuló szerkezeti ragasztóval és cementes-meszes

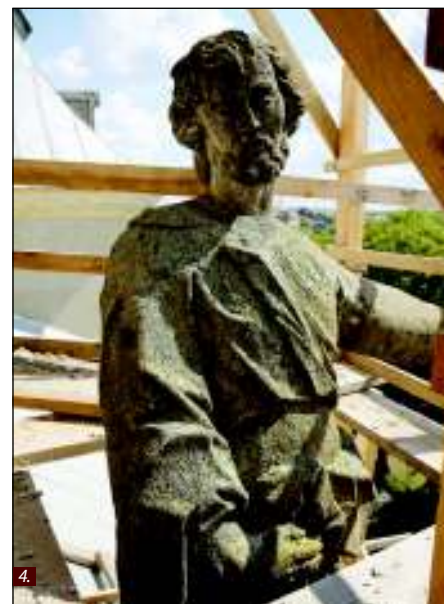
4.

■ **Foto 3.** Scoabe metalice corodate ■ **Foto 4.** Statuia superioară de la colțul sud-estic al turnului
 ■ **Photo 3.** Corroded metal rods ■ **Photo 4.** The upper levels' statue from the south-eastern corner

■ The statues are made of individual blocks of volcanic tuff originating from Seini (Maramureș County) and their surfaces are highly deteriorated. The surfaces turned blackish and are heavily polluted with algae and lichens. The statues are also in a state of decay, on the one hand due to the erosion caused by meteoric water, and on the other, to the loss of elements, like arms that were sculpted separately and attached to the body by the means of metallic elements. The sculpted figures' arms have probably been repaired, reattached or even replaced several times already. It was noted that some elements were remade out of pieces of bricks and the missing parts were completed with cement-based mortar. Due to pollution, both colours and the areas that had supposedly been gilded are hardly noticeable nowadays. The damage is obvious especially on the statues' prominent parts, but their lower parts are quite damaged as well, with fissures and stone detachments probably also due to the corroded metallic rods endangering the statues' safety. Subsequent repairs can be noticed on each of the eight statues, carried out with a darker mortar with high cement content.

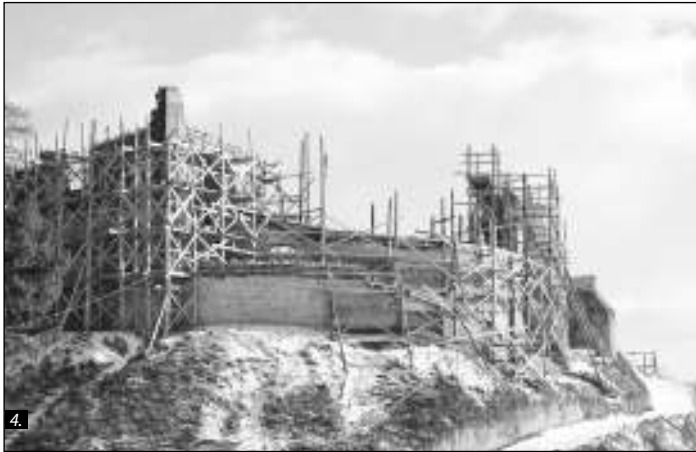
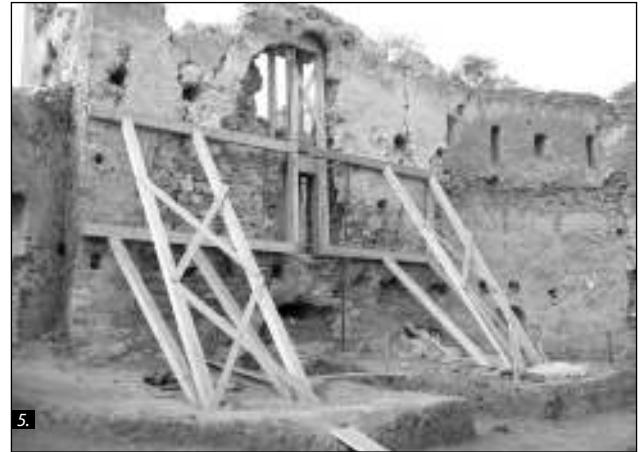
■ **Foto 4.** Cetatea văzută dinspre latura de S-V, cu turnul de vest și zidul de zwinger completat parțial (2013). © UTILITAS. ■ **Foto 5.** Turnul de vest cu sprijiniri provizorii, vedere dinspre interiorul incintei (2013). © UTILITAS
 ■ **Photo 4.** The fortress seen from the S-V side, with the western tower and the completed partially zwinger wall (2013). © UTILITAS. ■ **Photo 5.** Western tower with provisional buttress, seen from the enclosure (2013). © UTILITAS

Turnul de vest are zidurile păstrate pe toate laturile, pe înălțimea a trei niveluri cu probleme grave de stabilitate pe laturile dinspre incintă. Zidurile au mai multe crăpături verticale, golurile de ușă de la nivelurile superioare s-au

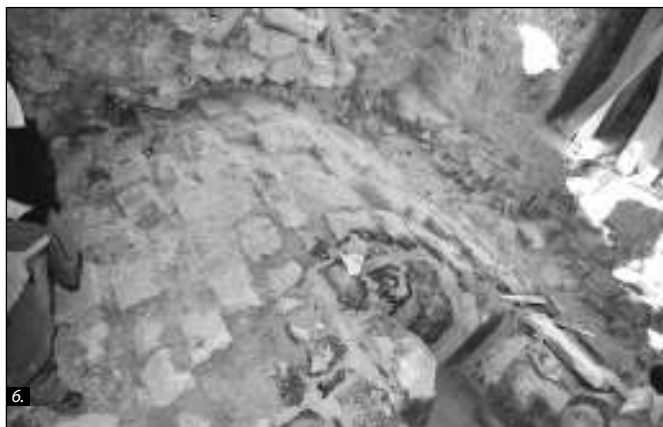
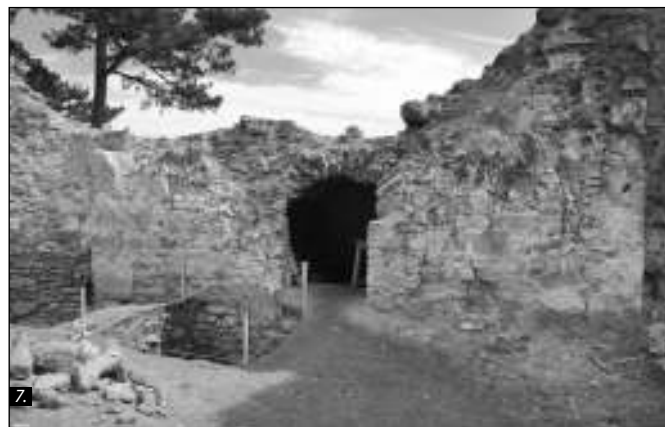
■ **Foto 6.** Bolta cilindrică din piatră refăcută la turnul de vest. © UTILITAS. ■ **Foto 7.** Fațada de vest al turnului de est, cu golul de acces, al încăperii de la parter, după degajarea umpluturilor. © UTILITAS
 ■ **Photo 6.** Rebuilt stone barrel vault at the western tower. © UTILITAS. ■ **Photo 7.** The western elevation of the eastern tower, with the access to the ground floor room, after the removal of the filling. © UTILITAS

a servi ca spații de expoziție. Anul trecut la turnul de vest s-a finalizat refacerea bolții din piatră de la parter, conform amprenteii bolții originale, urmând să se completeze șpaletii și arcele nișelor golurilor de tragere de la nivelurile superioare. La turnul de poartă, volumetria va fi sugerată printr-o structură din lemn pe un sigur nivel și acoperiș de protecție în două ape. La turnul de nord, după degajarea umpluturilor de pământ, s-au putut identifica dimensiunile planimetrice și poziția accesului dinspre curte. Acesta a fost urmat de completarea zidurilor până la nivel de parapet cu zidărie din piatră de calcar și refacerea golului de ușă. Restul nivelului urmează să fie completat cu o structură de lemn, învelit cu un acoperiș în patru ape, menit să creeze un accent pe latura de nord.

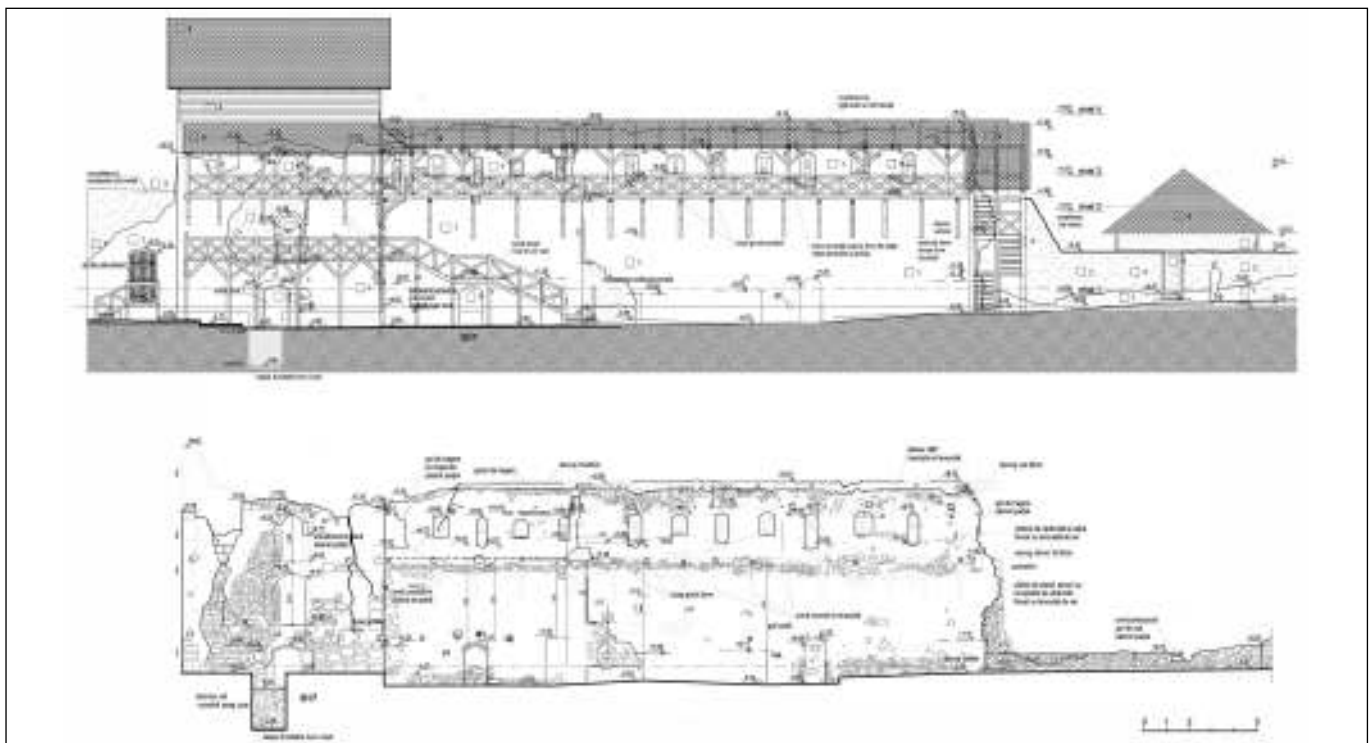
■ Fig. 2. Relevu (jos) și propunere (sus): zidul de incintă de N-V și turnul de vest, latura dinspre incintă.

■ Figure 2. Survey (bottom) and suggestion (top): the N-W enclosure wall and the western tower, the enclosure side.

In order to illustrate the volumes of the towers' upper part – on which we do not have enough data – it was proposed to use double wooden structures covered with boards at the wall's inner and outer limits, which will suggest the wall's thickness and the form of the niches and embrasures. The timber structure facilitates the upper closure of the towers using multi-pitched roofs, covered with shingle tiles.

The suggestion for the eastern and western tower is to rebuild the timber slabs, at the original benchmark of the levels. Thus, four rooms will result in the western tower and three in the eastern one, which will be illuminated and arranged as exhibition spaces. The reconstruction of the western tower's stone vault of the ground floor was finished last year, according to the original vault trace, to be followed by the completion of the recesses and arches of the embrasure niches at the upper levels. The volume of the gate tower

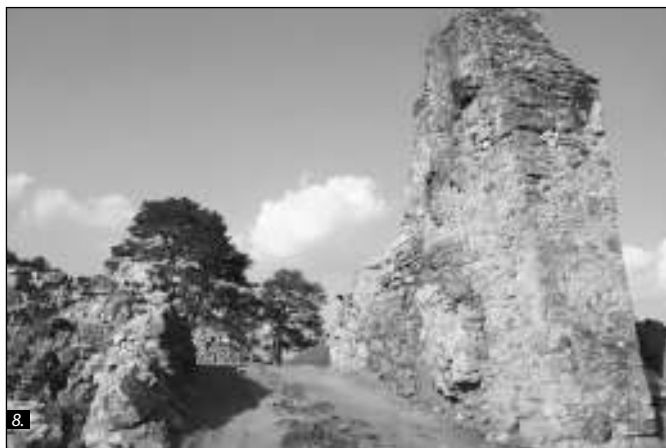
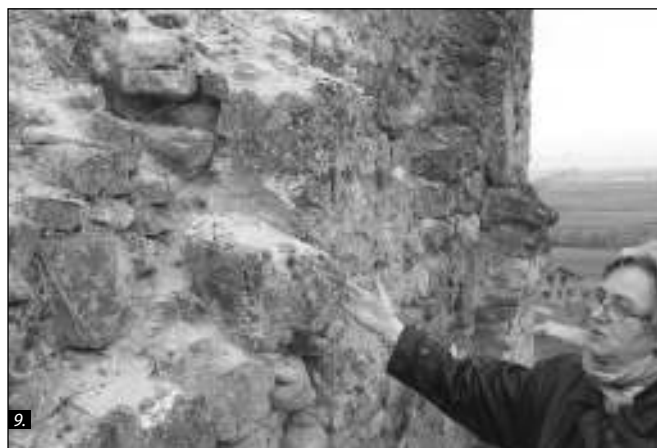
■ **Foto 8.** Ruinele zidurilor turnului de poartă, vedere dinspre sud. © UTILITAS. ■ **Foto 9.** Studiarea poziției arcelor pe latura de est a turnului de poartă împreună cu arh. Éva EKE. © UTILITAS
■ **Photo 8.** Ruins of the gate tower walls, seen from the south. © UTILITAS. ■ **Photo 9.** Study of the gate tower east side arches' position with architect Éva EKE. © UTILITAS

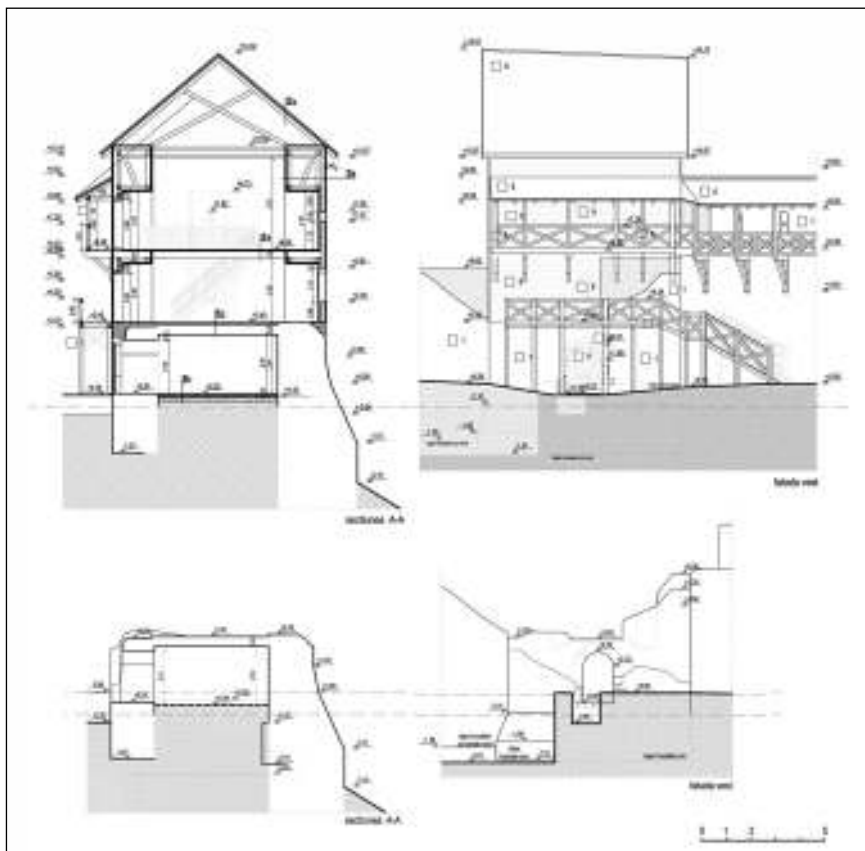
■ **Fig. 3.** Relevu (jos) și propunere (sus): secțiune și fațada vest al turnului de est.
■ **Figure 3.** Survey (bottom) and suggestion (top): cross-section and western elevation of the eastern tower.
